DUTCH
SAFETY BOARD

Preliminary report Crash involving Malaysia Airlines Boeing 777-200 flight MH17

Hrabove, Ukraine - 17 July 2014

Preliminary report

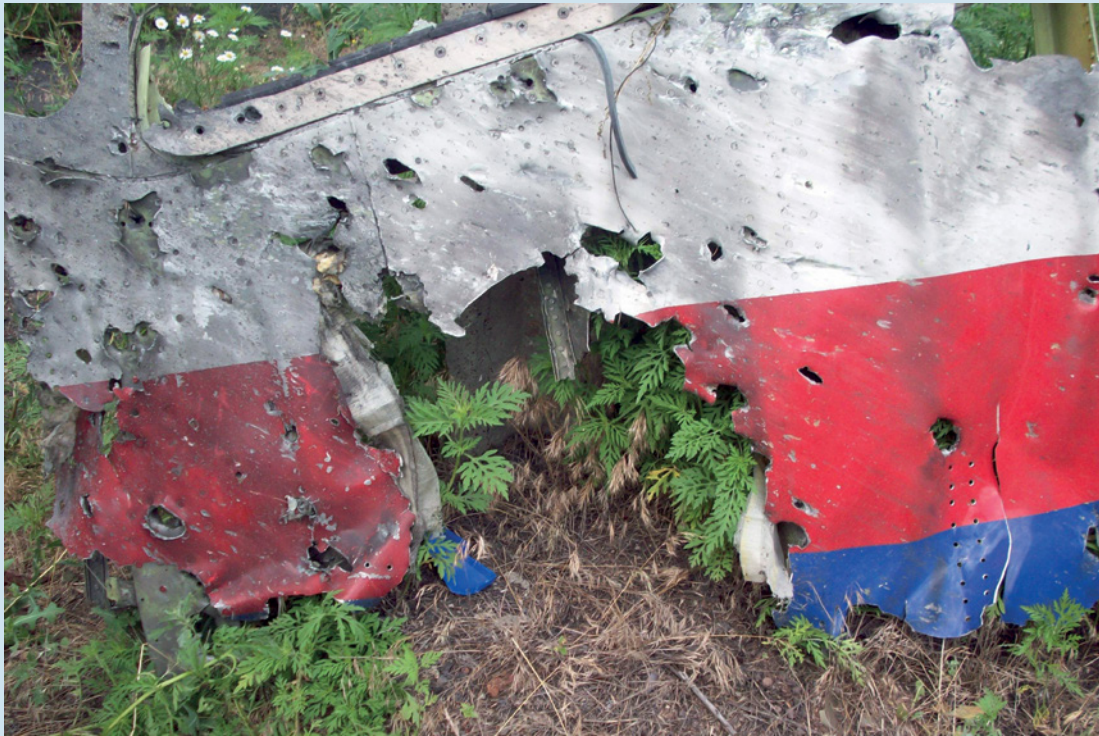
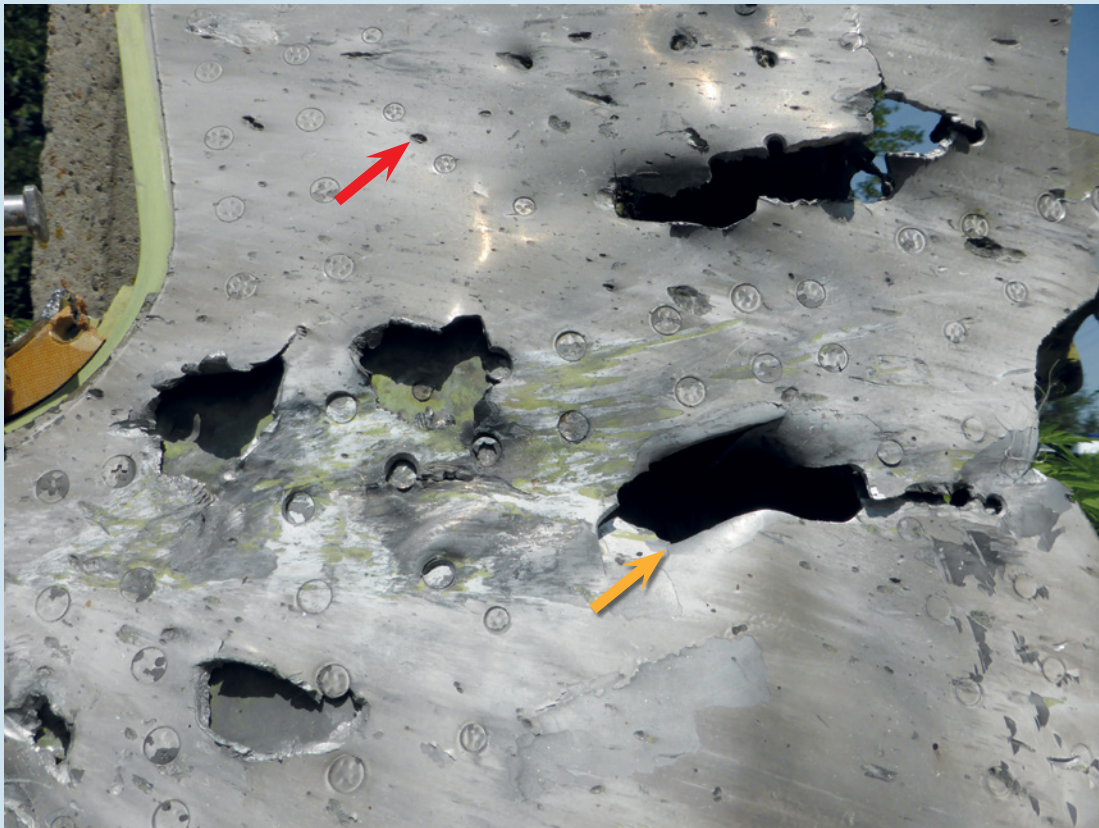
Photographs from the some wreckage showed that a number of pieces contained multiple holes and indentations. An example of a piece of wreckage containing such damage was a piece of skin from below the left cockpit window (figure 8) found in the town of Petropavlivka.

Figure 8: Forward fuselage skin from below the left cockpit window containing numerous small holes and indentations (above); enlarged image of the right upper corner of this skin (below) showing puncture holes (orange arrow) and pitting (red arrow). (Source: DCA and AFP)

Noting that the investigation team has not yet had the opportunity to recover these components for forensic examination, photographs from the wreckage indicated that the material around the holes was deformed in a manner consistent with being punctured by high-energy objects. The characteristics of the material deformation around the puncture holes appear to indicate that the objects originated from outside the fuselage.

The pattern of damage observed in the forward fuselage and cockpit section of the aircraft was consistent with the damage that would be expected from a large number of high-energy objects that penetrated the aircraft from outside.

Damage observed on the forward fuselage and cockpit section of the aircraft appears to indicate that there were impacts from a large number of high-energy objects from outside the aircraft.

The pattern of damage observed in the forward fuselage and cockpit section of the aircraft was not consistent with the damage that would be expected from any known failure mode of the aircraft, its engines or systems.

The damage observed in the forward section of the aircraft appears to indicate that the aircraft was penetrated by a large number of high-energy objects from outside the aircraft. It is likely that this damage resulted in a loss of structural integrity of the aircraft, leading to an in-flight break up.

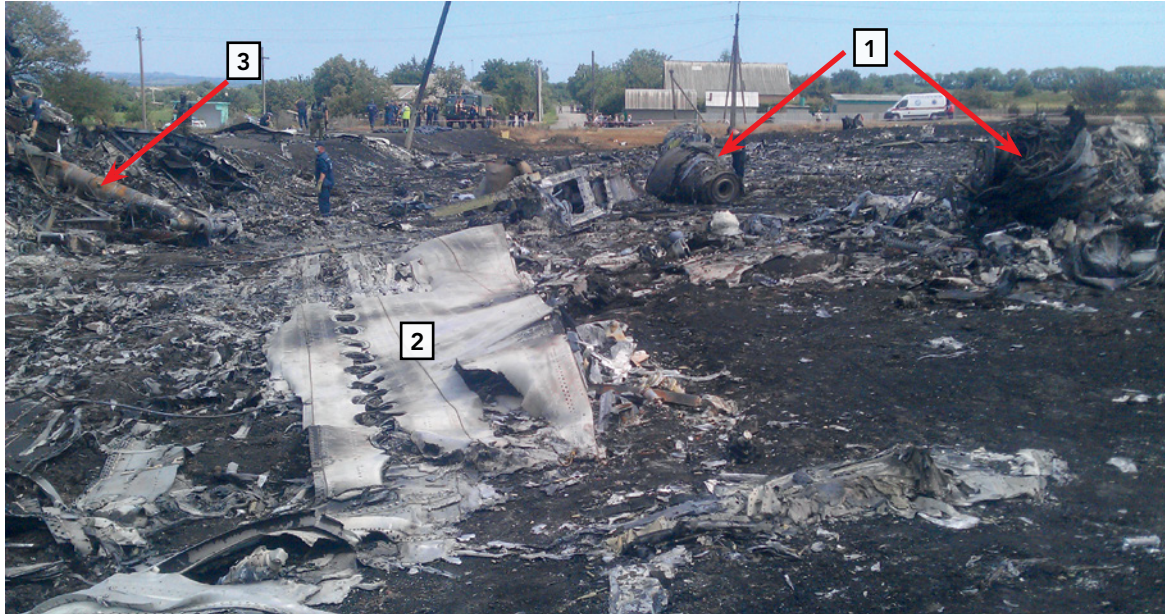
The main site was located at the south-western corner of the town of Hrabove, 8.5 km from the last recorded FDR position of the aircraft. This site contained parts of the wings, both engines, the main landing gear and a portion of the fuselage (figure 11). Aircraft parts distributed over the main site had been subjected to post crash fire.

Figure 11: Main wreckage site showing engine parts (1), wing with inspection hatches (2) and main landing gear (3). (Source: NBAAI)
