A Structural Reevaluation of the Collapse of World Trade Center 7

Draft

INE Report 18.17

September 2019

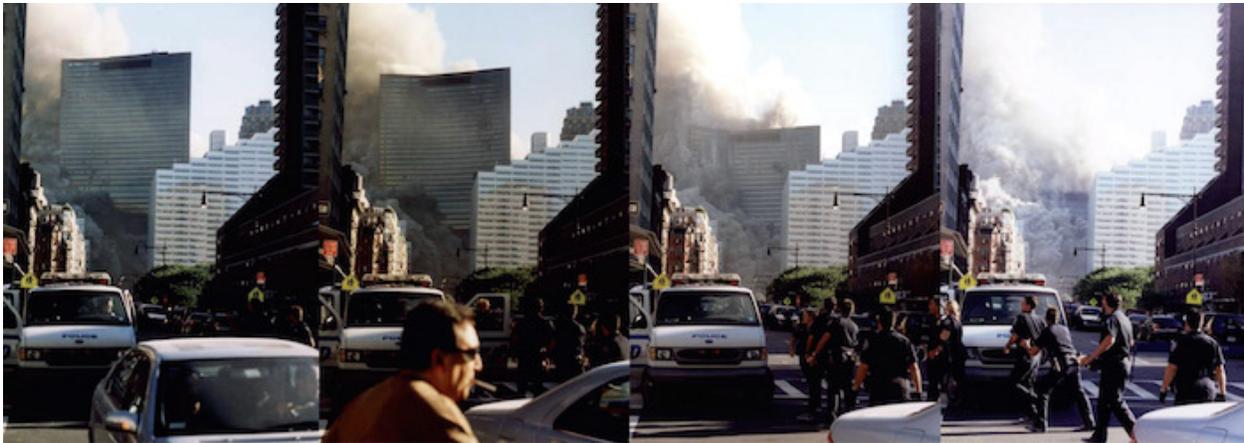
Figure 1.5 The collapse of WTC 7 at 5:20 PM (source unknown).

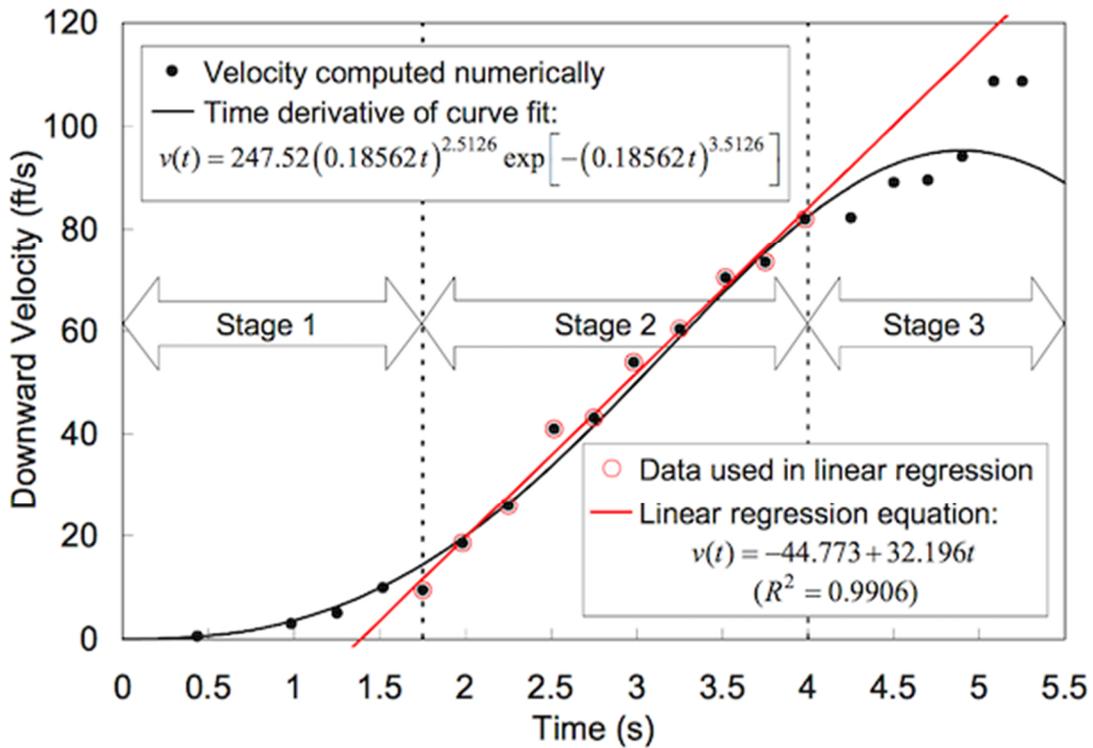
Figure 1.6 WTC 7 was in free fall for approximately 2.25 seconds over a distance of approximately 8 stories or 32.0 meters (NIST, 2008, NCSTAR 1A).

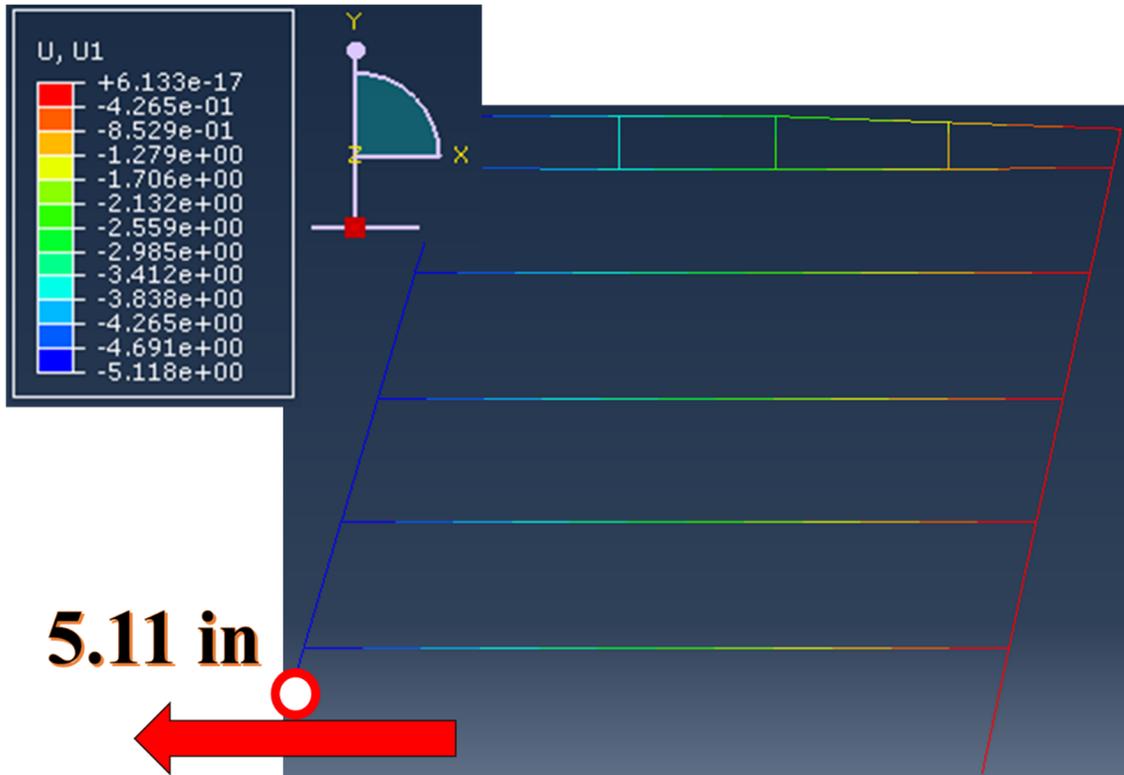
- Therefore, during our analysis of WTC 7's response to fire loading (Section 2.6), we found the overall thermal movements at the A2001 base plate support near Column 79 were not sufficient to displace girder A2001 to the point that it walked off its seat (the initiating failure alleged by NIST). Whereas NIST asserted that the differential westward displacement of girder A2001 relative to Column 79 was 5.5 inches and later revised its calculation to 6.25 inches, we found that the westward displacement of girder A2001

relative to Column 79 would have been less than 1 inch under the fire conditions reported by NIST.

Figure 2.65 Transverse displacement at the end of A2001 using the NIST assumptions.

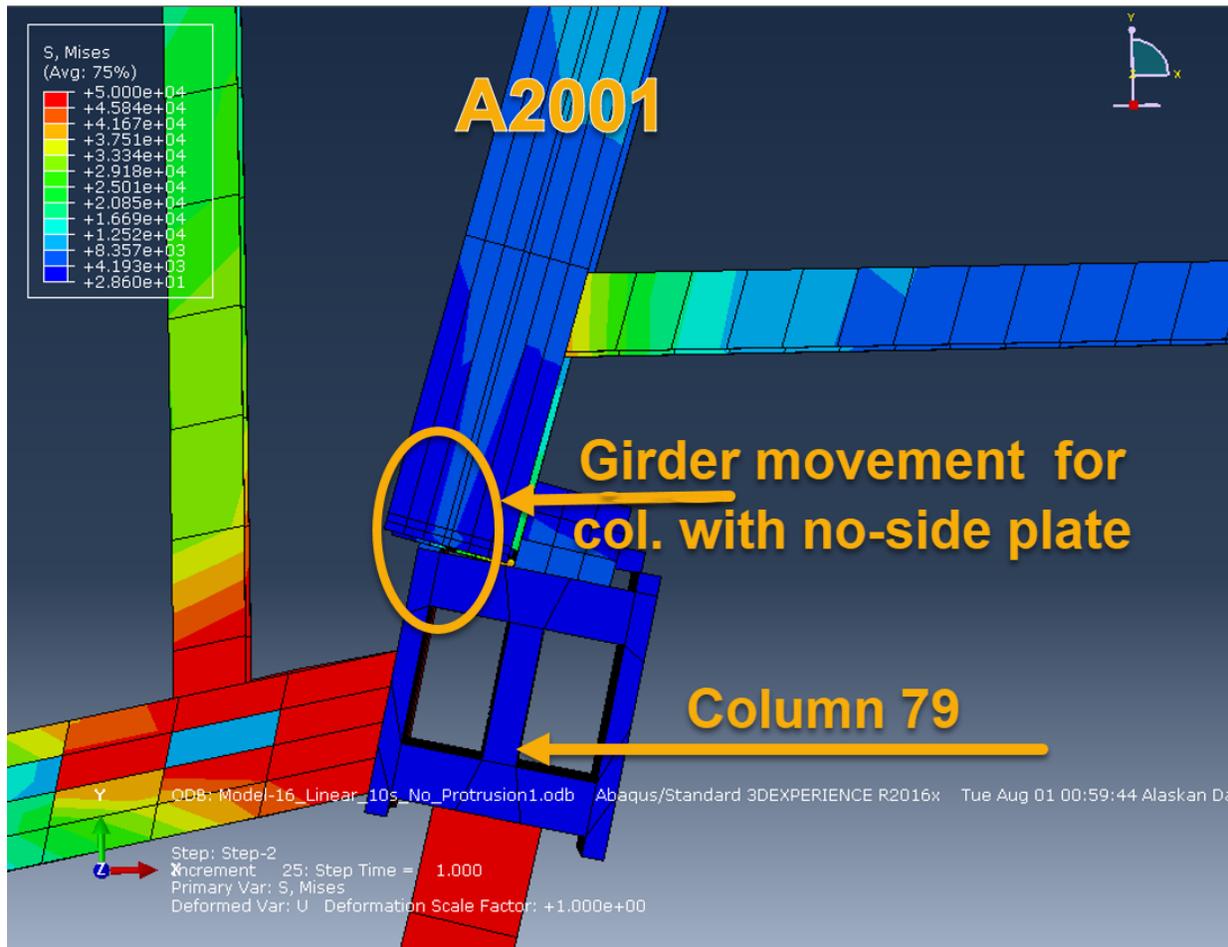
Figure 3.6 Plan view shows girder A2001 being pushed laterally past notched western side plate.

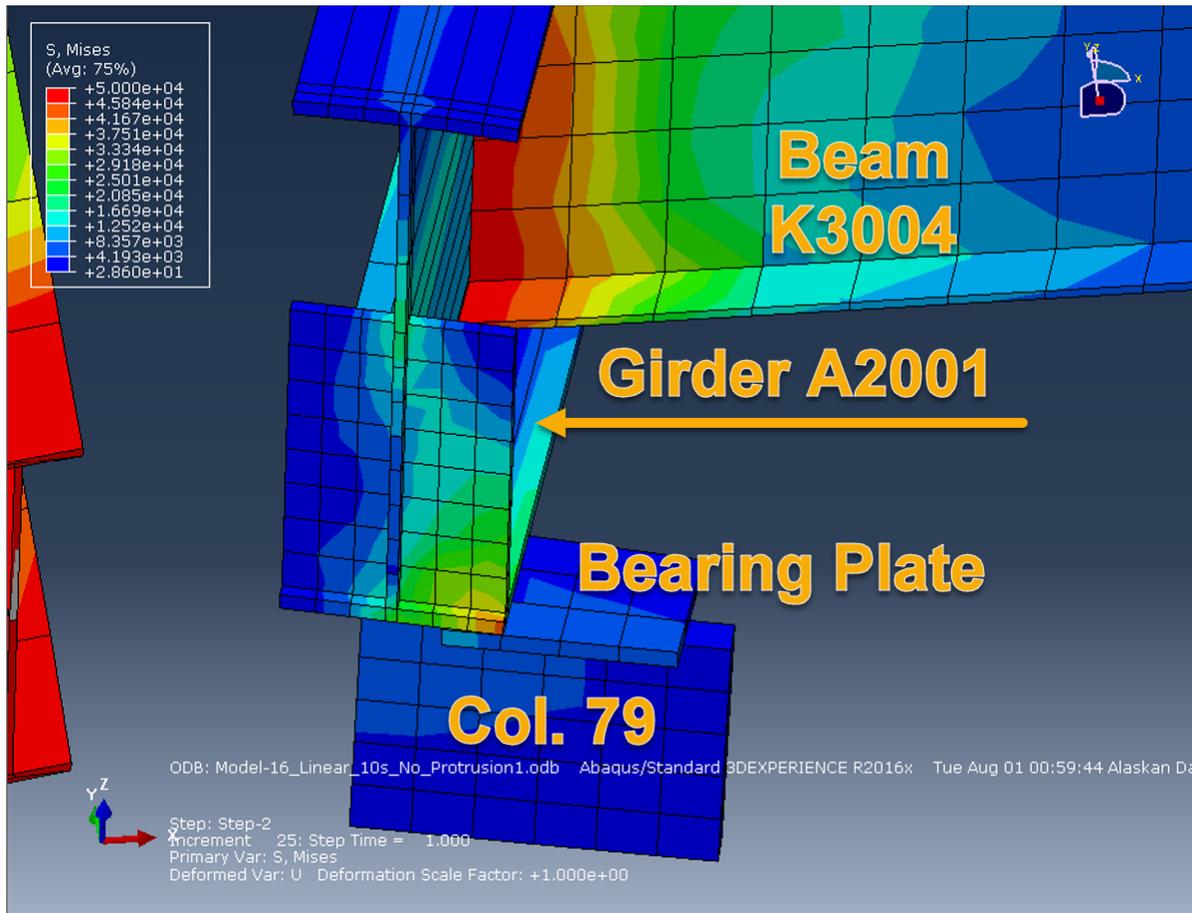
- Arup's finite element analysis corroborates our finding that girder A2001 would become trapped behind the western side plate of Column 79. However, Arup's analysis then goes on to contend that the five beams to the east of girder A2001 were heated enough to sag and pull the girder to the east and off of its seats. Putting aside whether this initiating mechanism is valid, we found that Nordenson incorrectly calculated the impact force of the falling girder by considering it as a point load, thus implying an infinite stiffness and no deflection. Calculating the impact force correctly, we found that it is only 34% of the 632,000 lb. force required to shear the girder bearing seat support welds at Floor 12. Therefore, the northeast corner of Floor 12 would not have collapsed if the Floor 13 girder came off its seat at Column 79, and a cascade of floor failures would not ensue.

Figure 3.7 Analysis showing girder web A2001 pushed laterally past the bearing seat at Column 79. The column is removed for clarity.

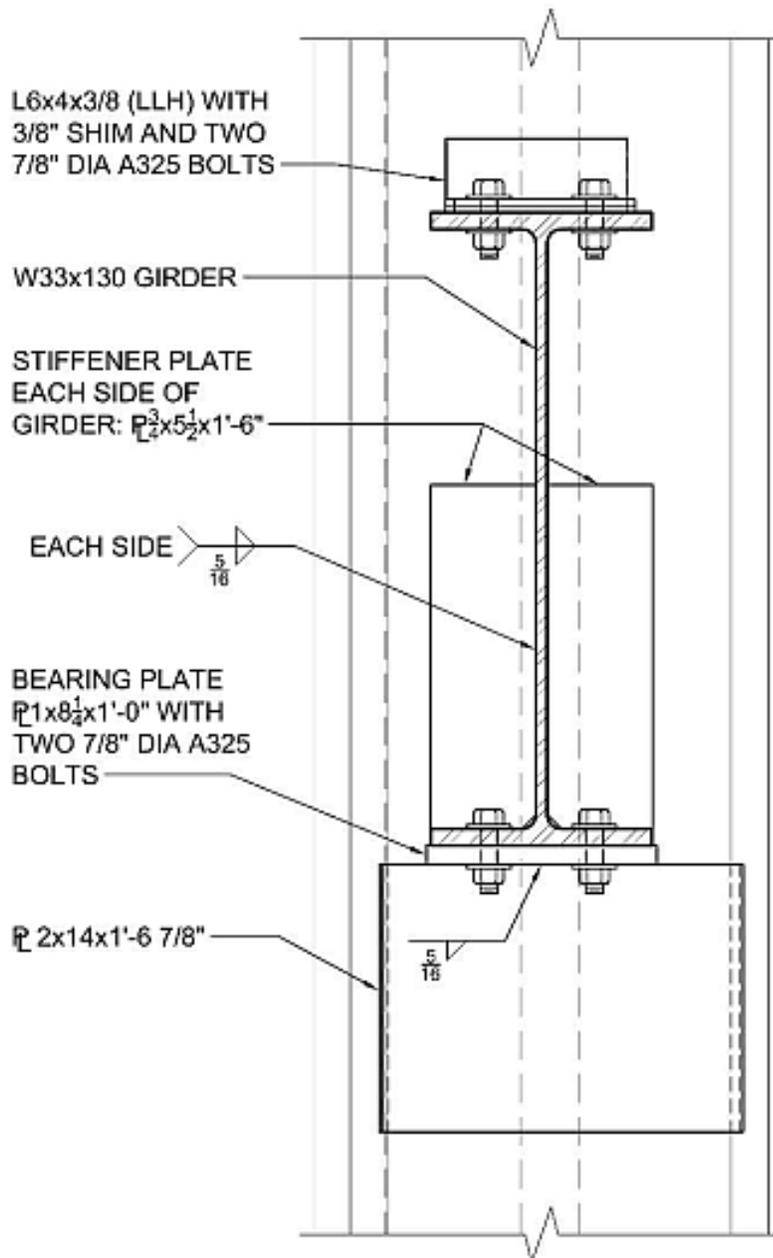
- NIST, by its own admission, did not include the partial height web stiffeners known to be on girder A2001. In addition to stiffening the web, these stiffeners significantly increase the bending resistance of the flange. In a subsequent analysis where we removed the side plate described in the previous analysis in order to allow for further westward travel of girder A2001, we found that the stresses in the girder flange and stiffener would not be sufficient to cause the flange to fail, thus preventing the girder from walking off its seat (Section 3.2.2).

Figure 3.10 Section view at Floor 13 of Column 79 and girder A2001 seated beam connection, which shows stiffener plates on girder A2001 (Data from Frankel Steel Limited, 1985, Drawing 9114; figure prepared by Brookman, 2012).

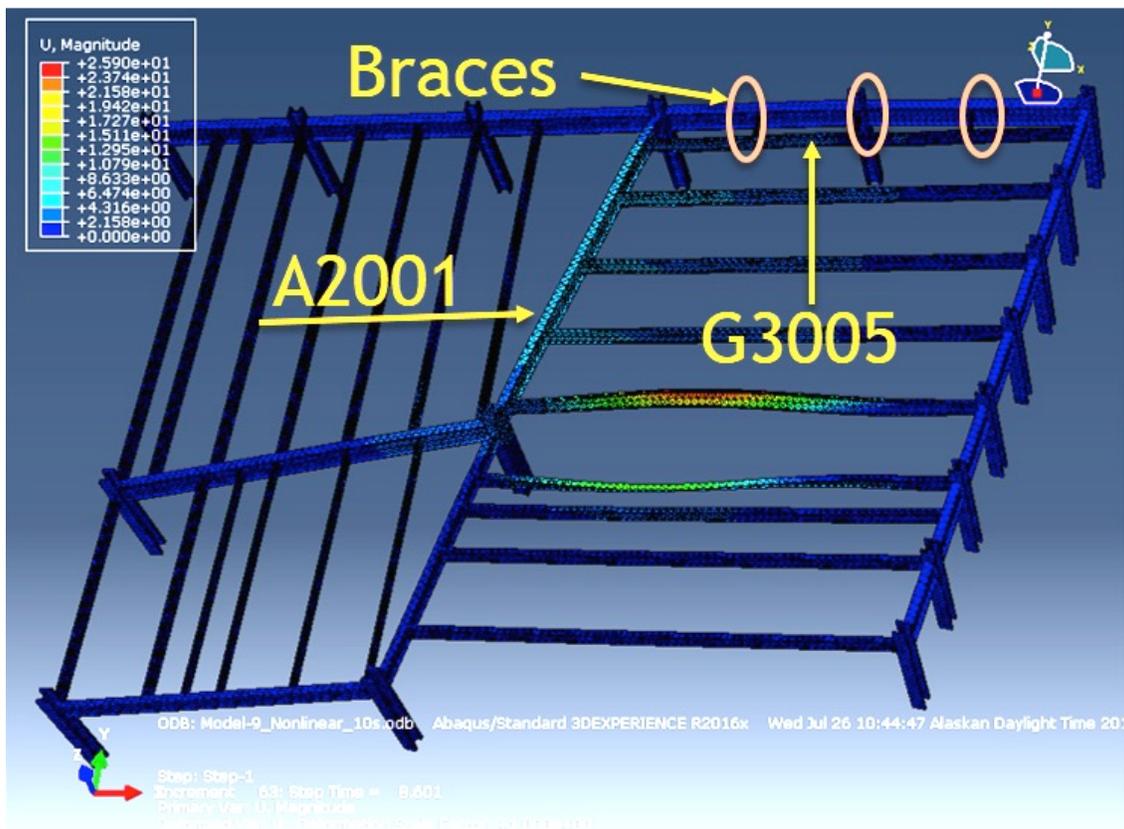
- In a preliminary collapse initiation hypothesis, NIST posited that beam G3005 buckled because its thermal expansion was restrained by girder A2001. We found that this can happen only when the three lateral support beams S3007, G3007, and K3007 spanning from beam G3005 to the north exterior wall are not included in the model. While these short beams are observed in some of the figures in the NIST report, they are missing from

Figure 3.11 UAF ABAQUS analysis shows beam G3005 does not buckle when braced by lateral support beams S3007, G3007 and K3007 (Frankel Steel Limited, 1985).

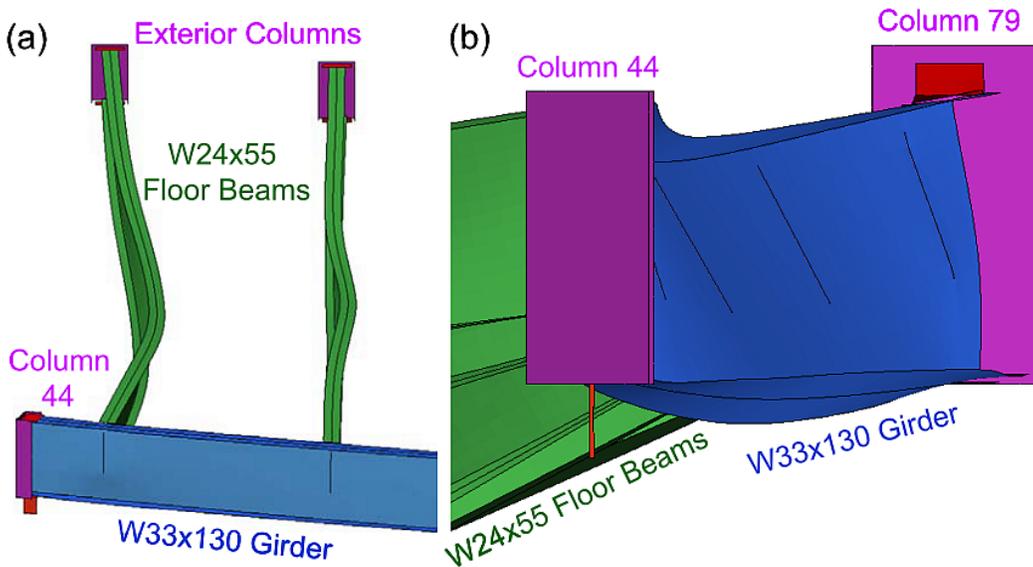
Figure 3.13 Figure 8-27 of the NIST report shows results of a finite element analysis where lateral support beams connecting to G3005 were not included (NIST, 2008, NCSTAR 1-9, Vol. 1, Page 354).

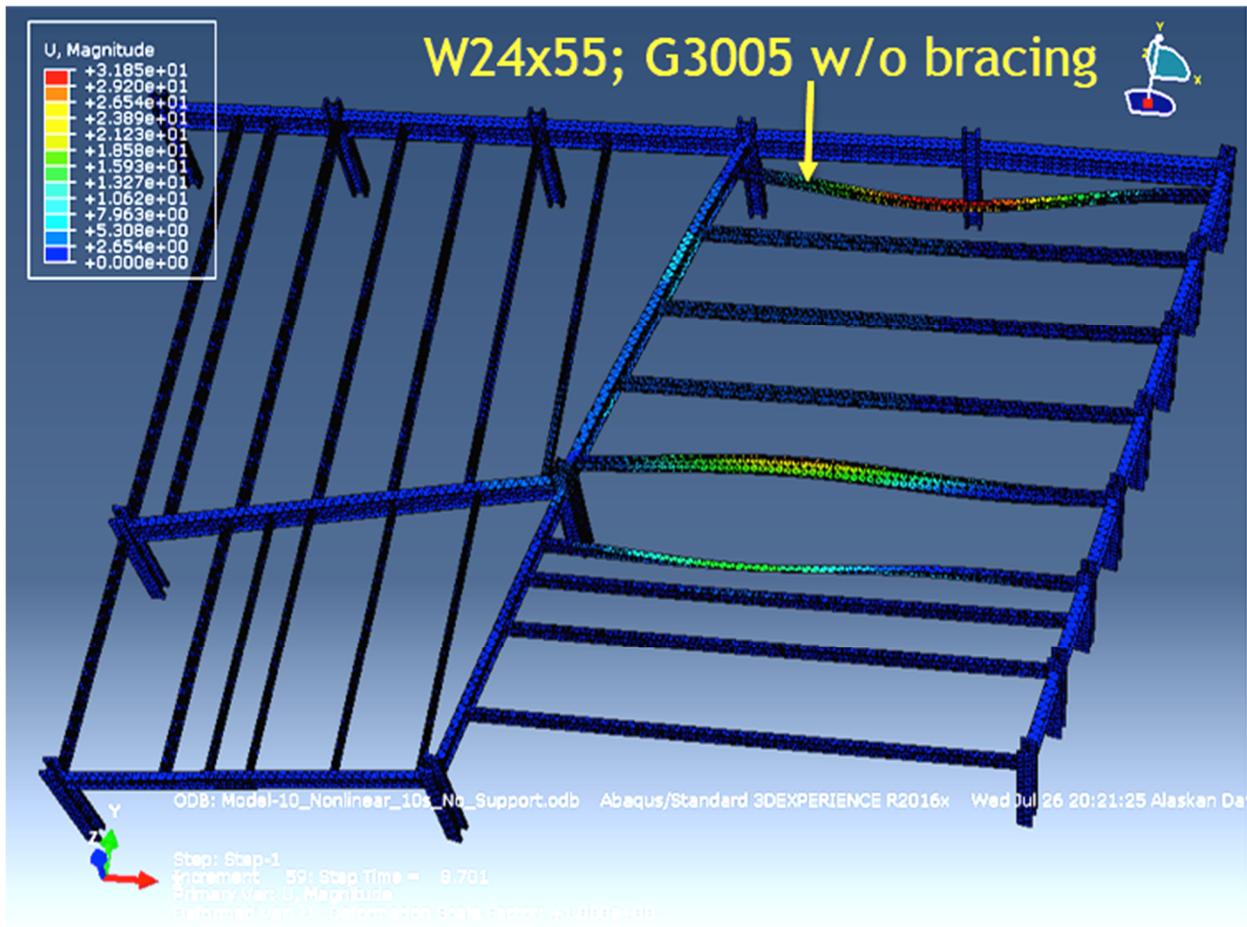
Figure 3.14 UAF analysis of the W21x44 G3005 with no lateral support beams included.

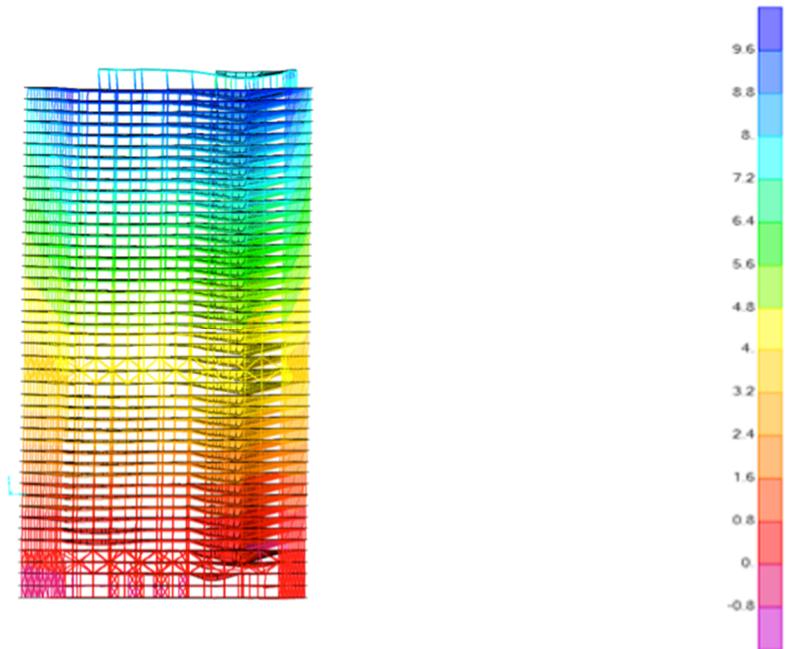
- Columns 79, 80, and 81 did not fail at the lower floors of the building, as asserted by NIST. In order to allow for the observed collapse of the east penthouse approximately 7 seconds prior to the collapse of the rest of the structure, these columns needed to have failed at the upper floors of the building all the way to the penthouse. Yet there were no documented fires above Floor 30. Therefore, fire did not cause the collapse of Columns 79, 80, and 81 nor the collapse of the east penthouse (Section 4.3).

Figure 4.2: Columns 79, 80, and 81 are removed from Floor 6 to Floor 13. The building tilts to the east almost 10 inches. The penthouse does not collapse.

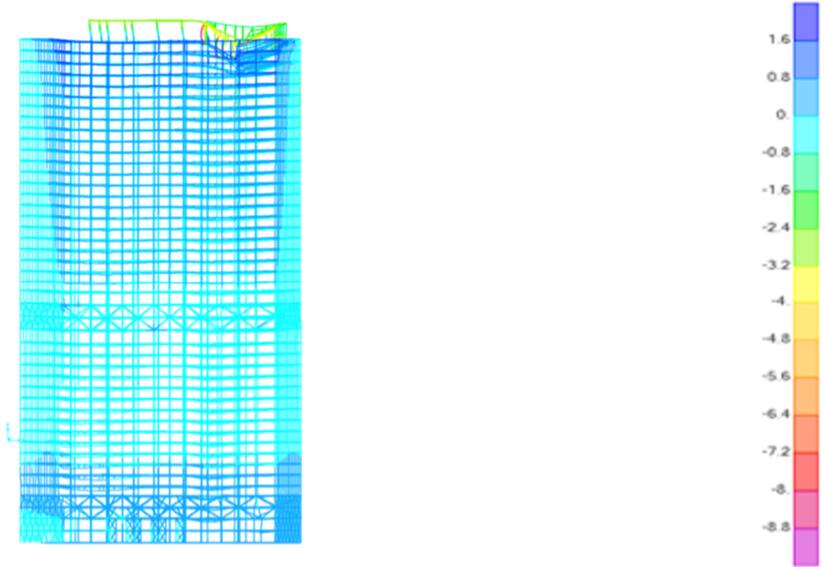
Figure 4.7: Columns 79, 80, and 81 are removed from Floor 45 to the penthouse. Tilting of the building is now negligible. The penthouse now collapses, as demonstrated from the significant amount of deflection given in the figure.

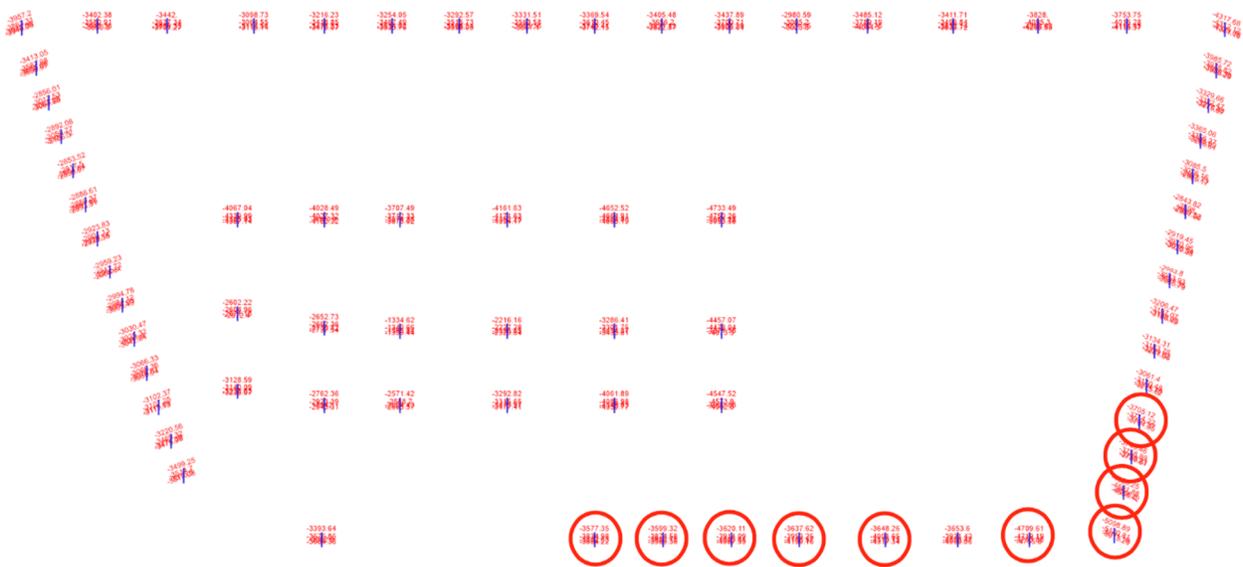
- Even if we assume the failure of Columns 79, 80, and 81 could lead to the failure of the next row of core columns, the hypothetical failure of Columns 76 to 81 would overload the exterior columns around the southeast of the building, rather than overloading the next row of core columns to the west, which would result in the building tipping to the southeast and not in a straight-down collapse (Section 4.4).

Figure 4.10: Linear static analysis results show that the failure of Columns 76 to 81 overloads 10 exterior columns (circled in red) around the southeast corner, but not the next row of core columns to the west (not circled in red).

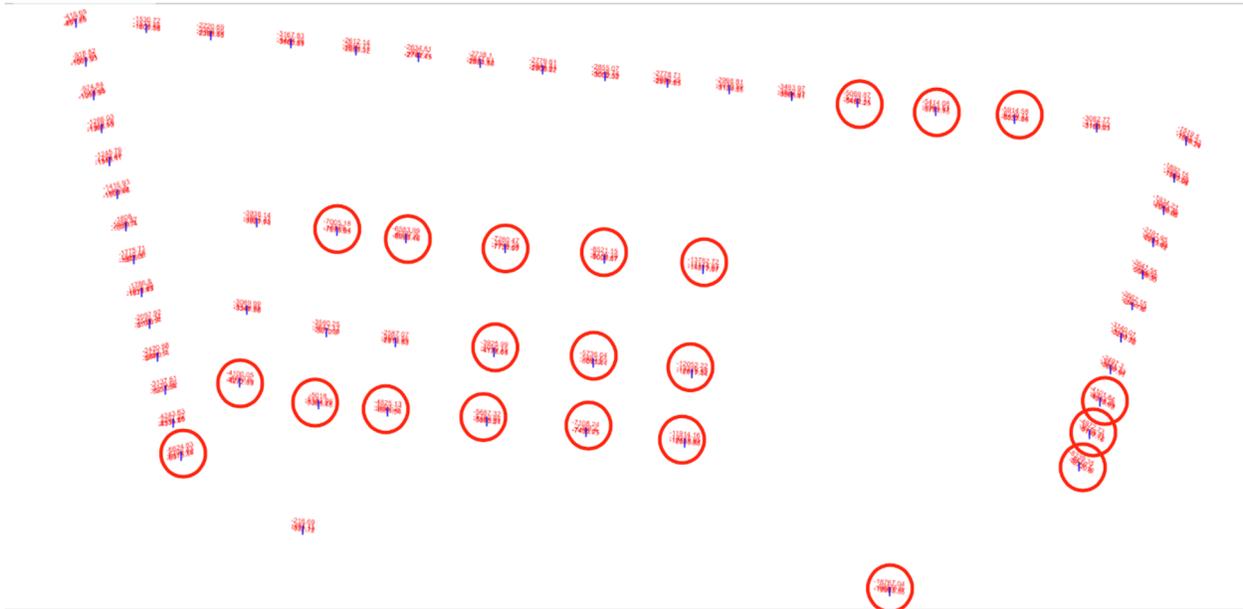
Figure 4.11: Linear static analysis results show that the failure of 10 exterior columns around the southeast corner leads to numerous core and exterior columns (circled in red) being overloaded and failing. A progressive collapse triggered by the hypothetical failure of Columns 76 to 81 is underway.

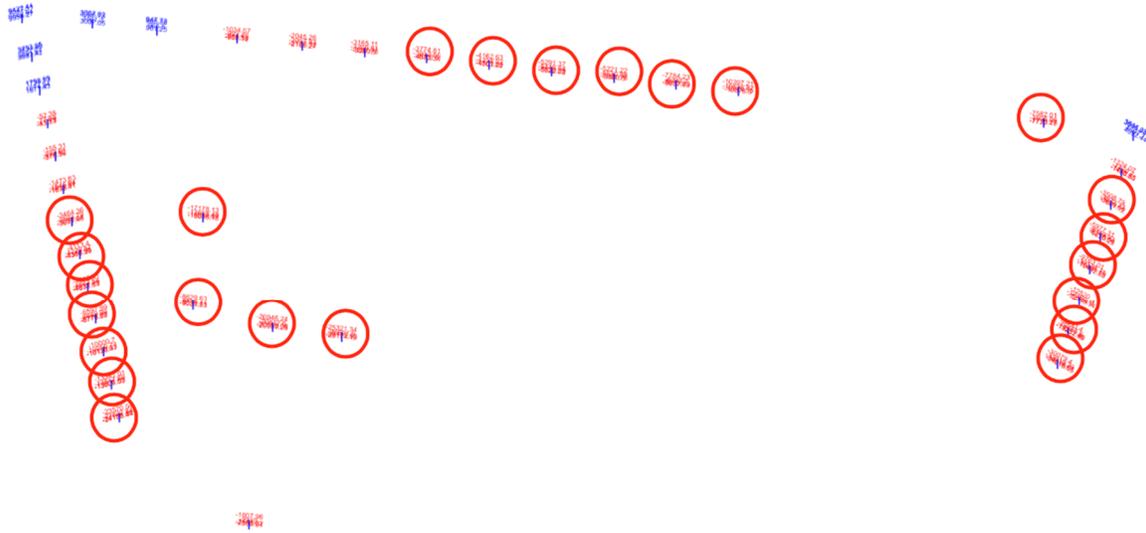
Figure 4.12: Linear static analysis results show that the failure of additional columns (shown in Figure 4.11 above) leads to the failure of the remaining core columns and many exterior columns (circled in red). The columns with blue values are in tension rather than compression, indicating the building is tipping away from those columns.

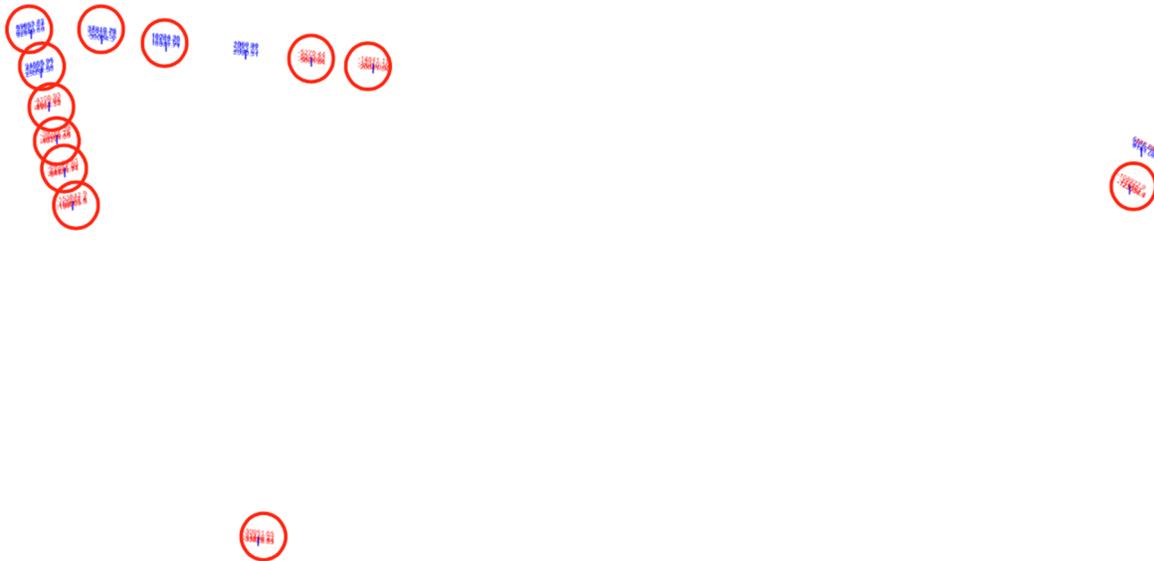
Figure 4.13: Linear static analysis results show that the failure of additional columns (shown in Figure 4.12 above) leads to the failure of nearly every remaining column (circled in red).

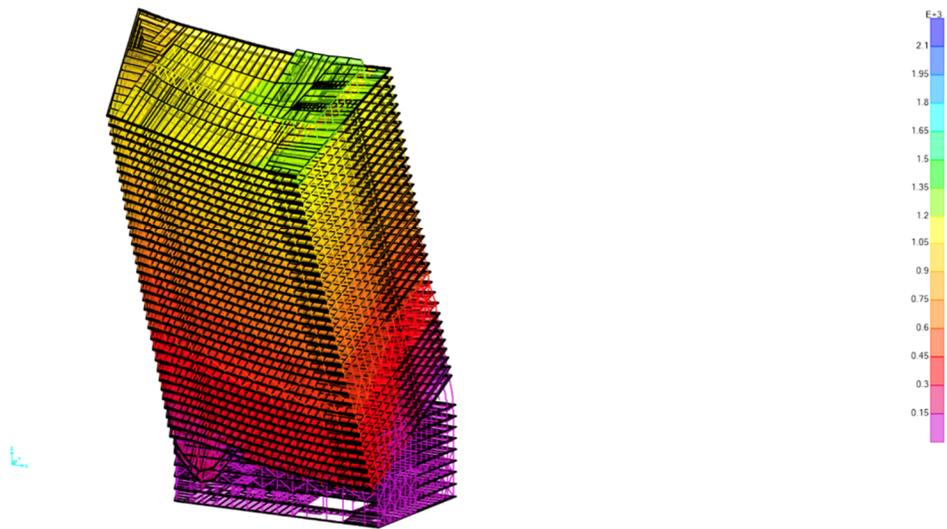
Figure 4.14: Visualization of linear static analysis, from the southeast, showing the building tipping to the southeast after the hypothetical failure of Columns 76 to 81.

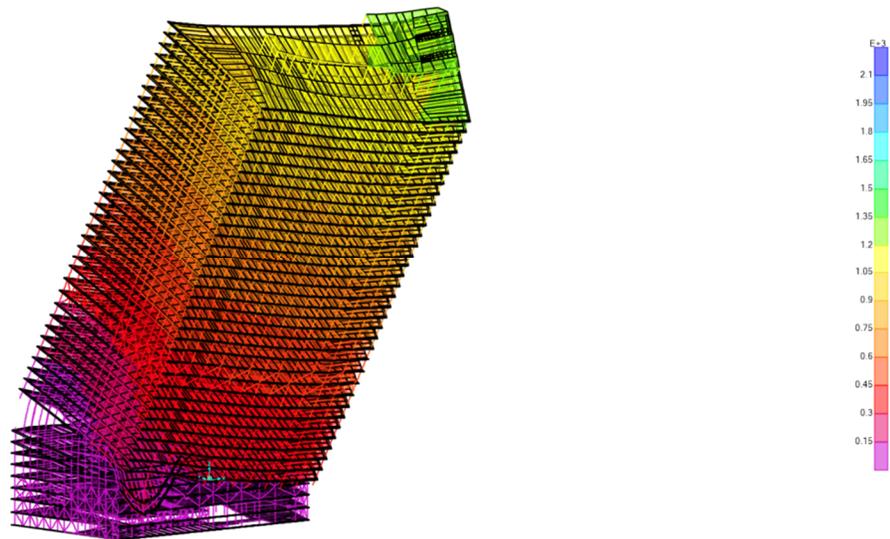
Figure 4.15: Visualization of linear static analysis, from the southwest, showing the building tipping to the southeast after the hypothetical failure of Columns 76 to 81.

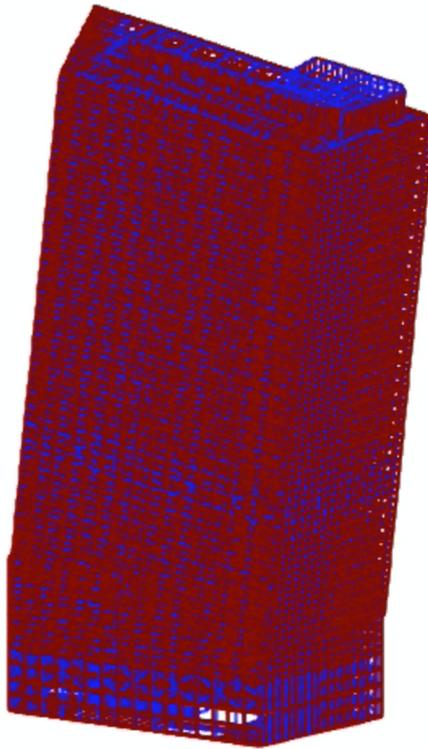
Figure 4.16: Dynamic analysis results showing the building tipping to the southeast after the hypothetical failure of Columns 76 to 81.

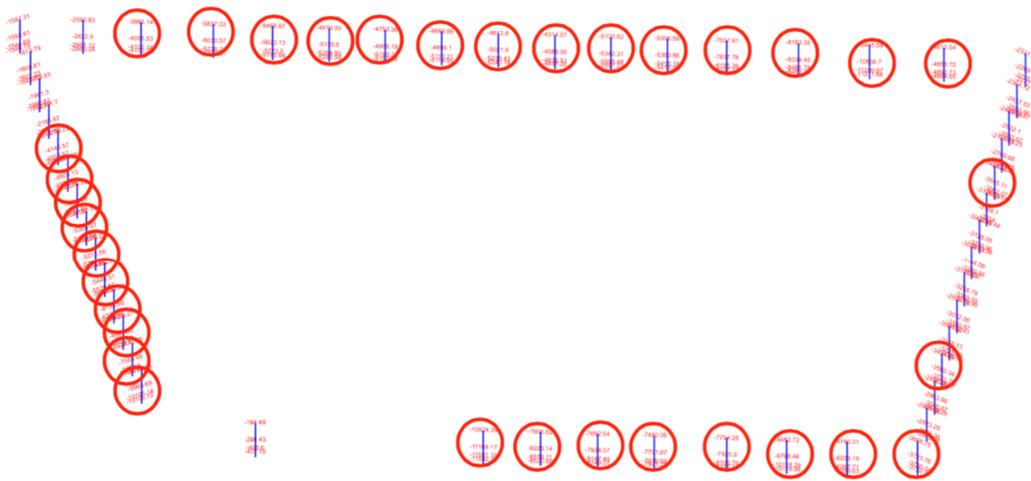
- The hypothetical simultaneous failure of all core columns (but not exterior columns) would cause the building to tip to the southwest rather than causing a straight-down collapse (Section 4.5).

Figure 4.17: Linear static analysis results show that the simultaneous failure of all core columns leads to the failure of most exterior columns, causing the building to tip to the southwest. Only columns at the northwest corner and eastern side are not overloaded.

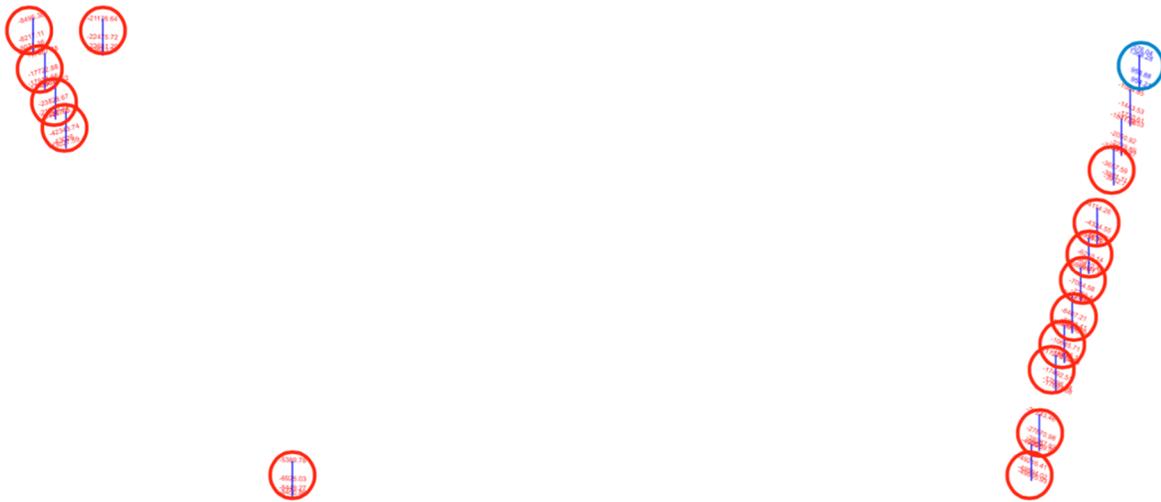
Figure 4.18: Linear static analysis results show the failure of nearly all remaining columns. The northeast column with blue values is in tension as the building tips away to the southwest.

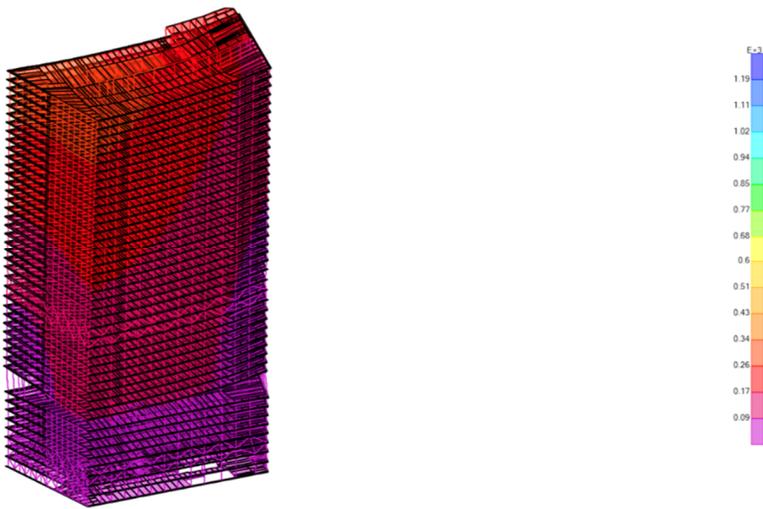
Figure 4.19: Visualization of linear static analysis, from the southwest, showing the building tipping to the southwest after the hypothetical simultaneous failure of all core columns.

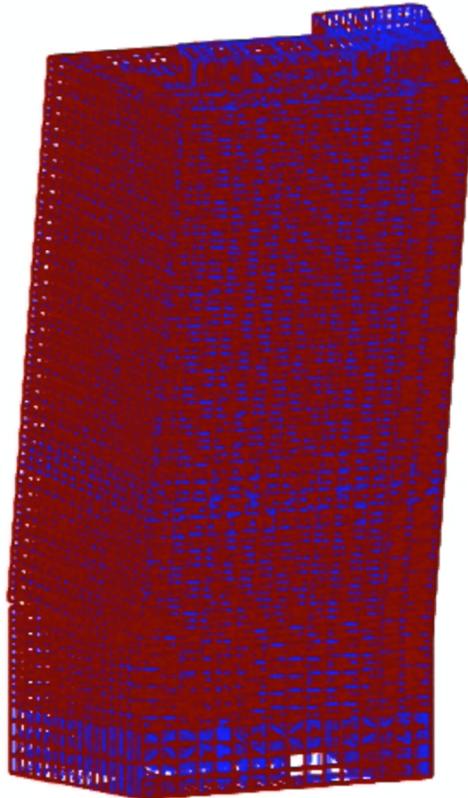
Figure 4.20: Dynamic analysis results showing the building tipping to the southwest after the hypothetical simultaneous failure of all core columns.

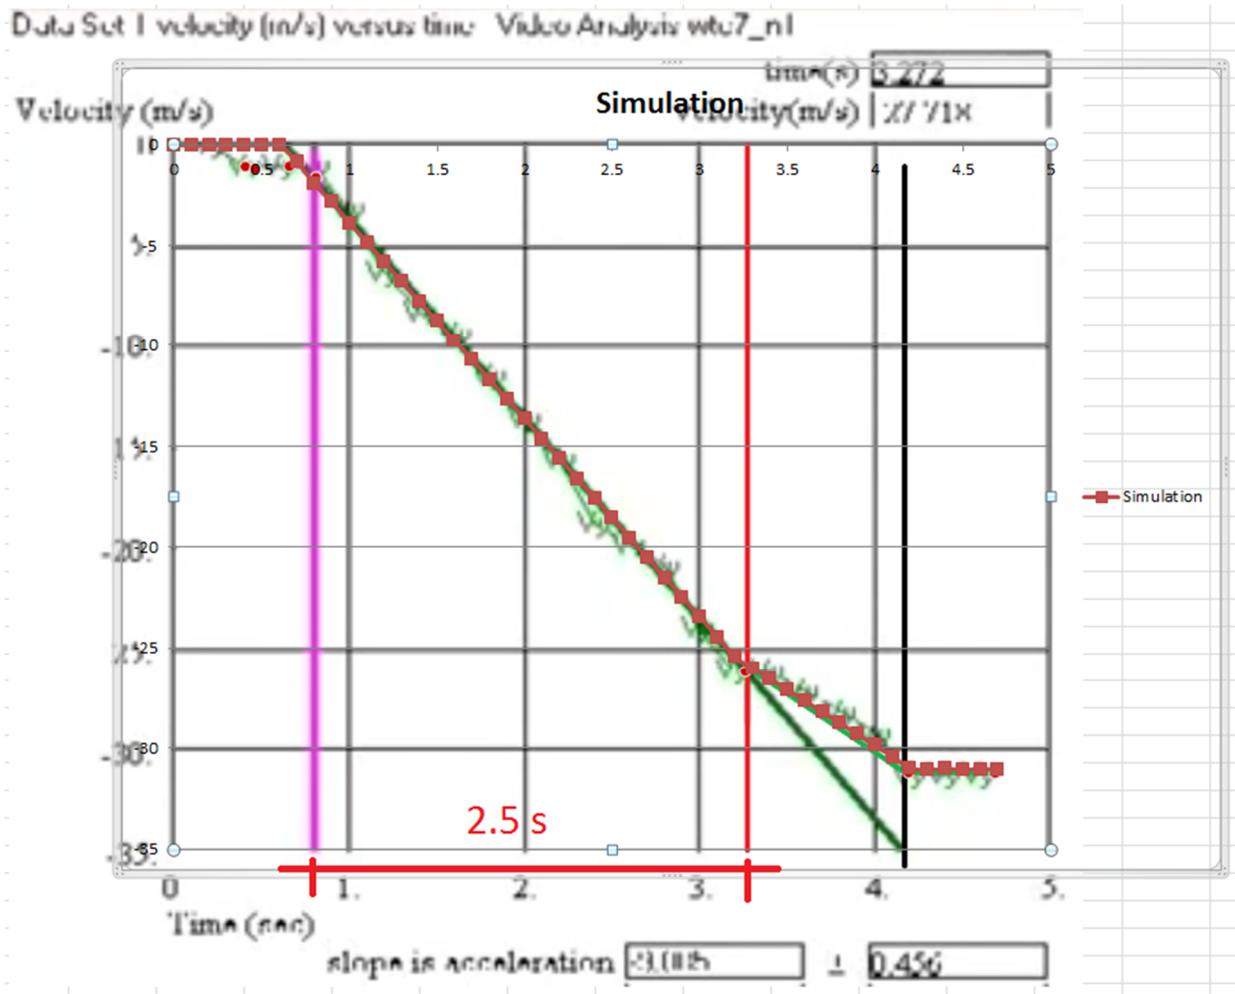
- The simultaneous failure of all core columns over 8 stories followed 1.3 seconds later by the simultaneous failure of all exterior columns over 8 stories produces almost exactly the behavior observed in videos of the collapse. The collapse could have started at Floor 16 and below and produced the same behavior (Section 4.6).

Figure 4.23: Velocity comparison between Chandler measurement (green plotted line) and UAF simulation (red plotted line). Bold green trend line illustrates free fall.
