A Structural Reevaluation of the Collapse of World Trade Center 7

Draft

INE Report 18.17

September 2019

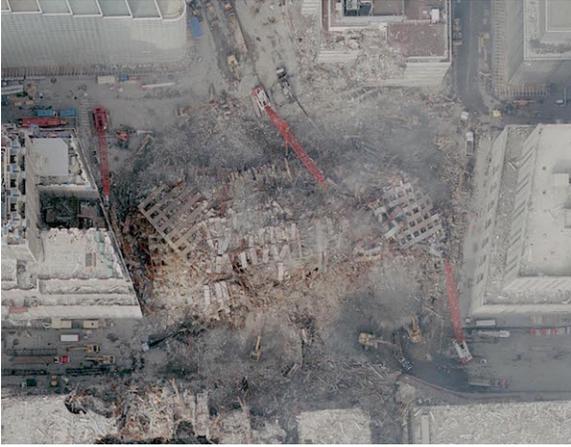
2. The debris pile of WTC 7 was contained mostly inside the building's footprint. Furthermore, it did not have large pieces of concrete flooring or intact structural framing that would be expected in a building collapse (see Figure 1.7).

Figure 1.7 WTC 7 debris pile (NOAA, September 23, 2001).

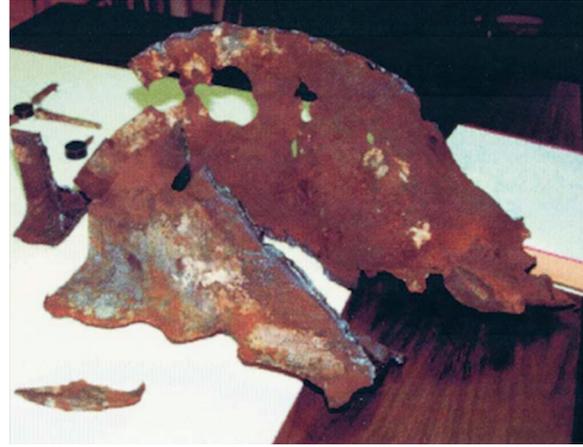
3. According to Appendix C of FEMA's May 2002 report, a steel member recovered from WTC 7 was found to have experienced corrosion due to a combination of oxidation and sulfidation at 1,000°C, resulting in the formation of a liquid eutectic (see Figure 1.8). Researchers have hypothesized that the presence of thermate, which is a form of thermite

Figure 1.8 Steel from WTC 7 that experienced oxidation and sulfidation (FEMA, 2002).

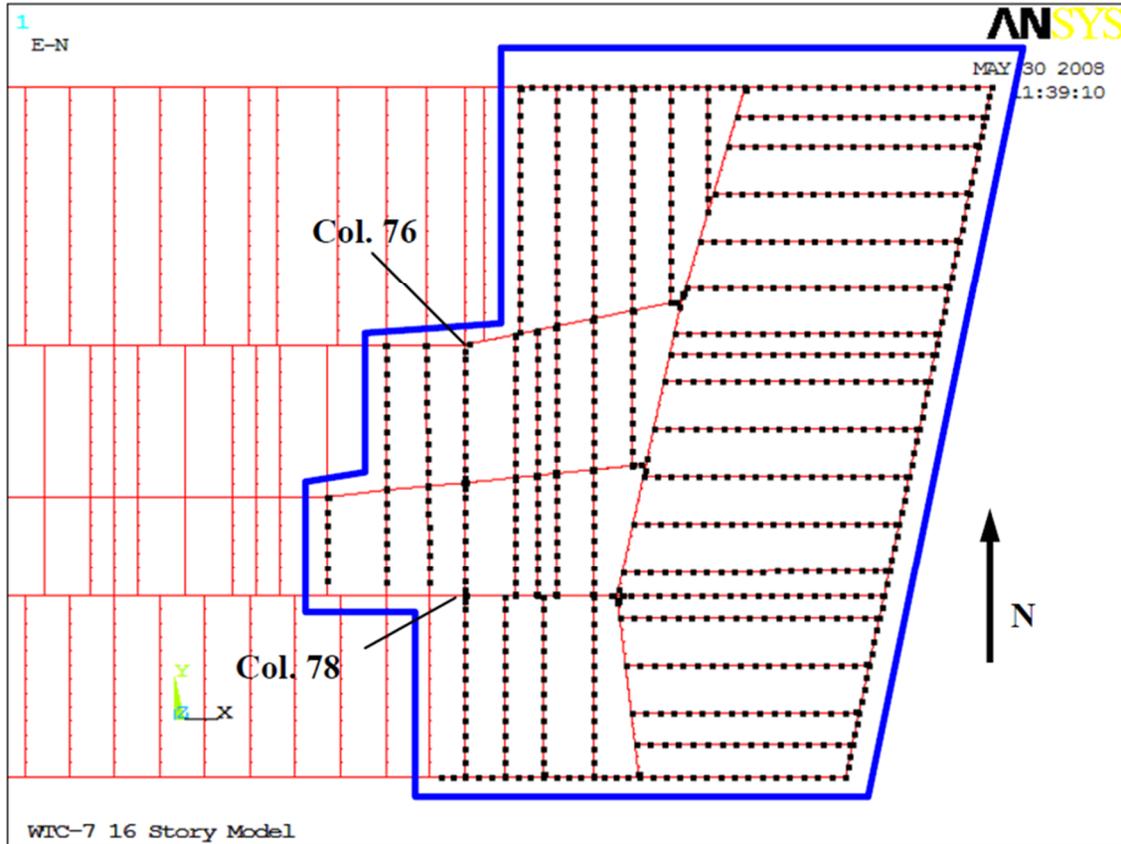
In the NIST investigation, the failure of the floor-framing connections and the shear studs was modeled with break elements on Floors 8 to 14. Outside the selected area in Figure 2.4 shown below, structural damage — such as buckling of the steel frame and crushing and

cracking of the concrete slab — was modeled over the entire floor, but connection failures were not modeled over the entire floor. Connections were also not modeled in the exterior moment frame, as no failures were observed there prior to the onset of global collapse (NIST, 2008, NCSTAR 1A).

Figure 2.4 Area of floor where connection failure was modeled by NIST

First, by not modeling connections in the outside frame, NIST overestimated the rigidity of the outside frame. That assumption and inconsistent modeling for the framing connections resulted in the stiffness of the east side of the building being different than that of the west side. This resulted in the stiffness being compromised across the plan of the building.

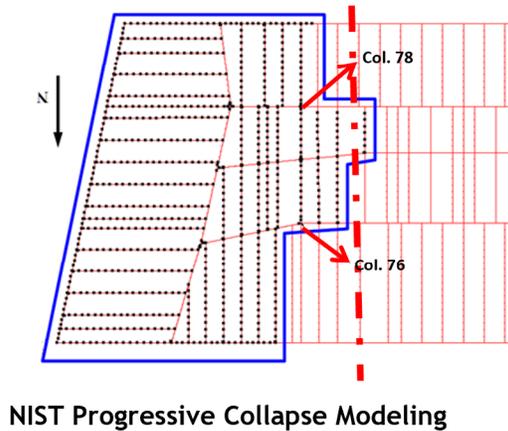
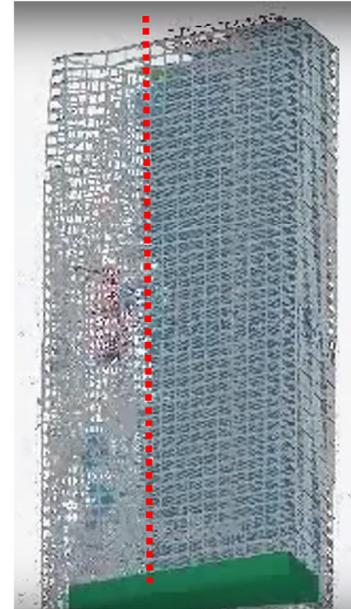
The NIST simulation of the collapse illustrated that the west side of the building acted differently from the east side. The structural response to failure would more closely resemble the actual collapse if the connections had been accounted for throughout the structural frame. By not modeling the connection failures outside the selected area shown in Figure 2.4 above, NIST appears to have reduced the stiffness in the area outside the selected area and separated its progressive collapse simulation into two parts (see Figure 2.5).

Connections were not modeled; outside selected blue space.

Figure 2.5 Progressive collapse separated into two parts.

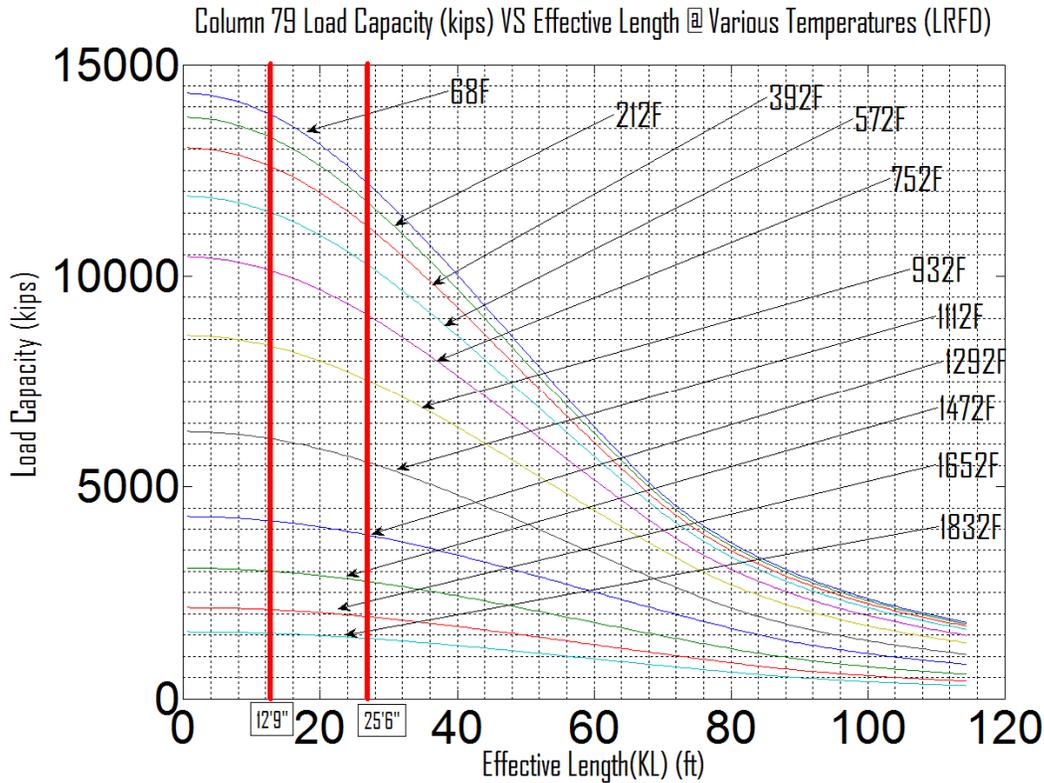
Figure 2.17 Load capacity of Column 79 versus effective length at different temperatures.

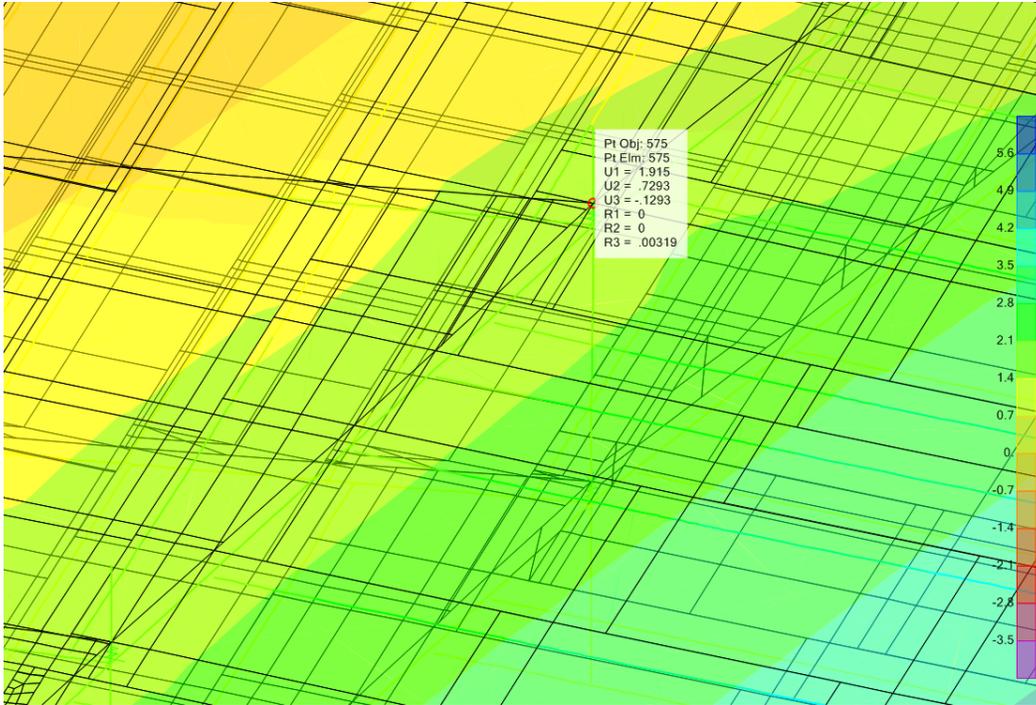
Figure 2.58 Displacement (inches) of the floor system surrounding Column 79.

Figure 2.58 shows the displacement of the floor system surrounding Column 79. The displacement at Column 79 in the x -direction was 1.915 inches east (and not west), and the displacement at Column 79 in the y -direction was 0.7293 inches. Note that this is the overall displacement of the floor system. The westward displacement of girder A2001 relative to Column 79 was found to be less than 1 inch, which differs substantially from the 6.25 inches of westward movement of girder A2001 reported by NIST. We believe this is because NIST treated

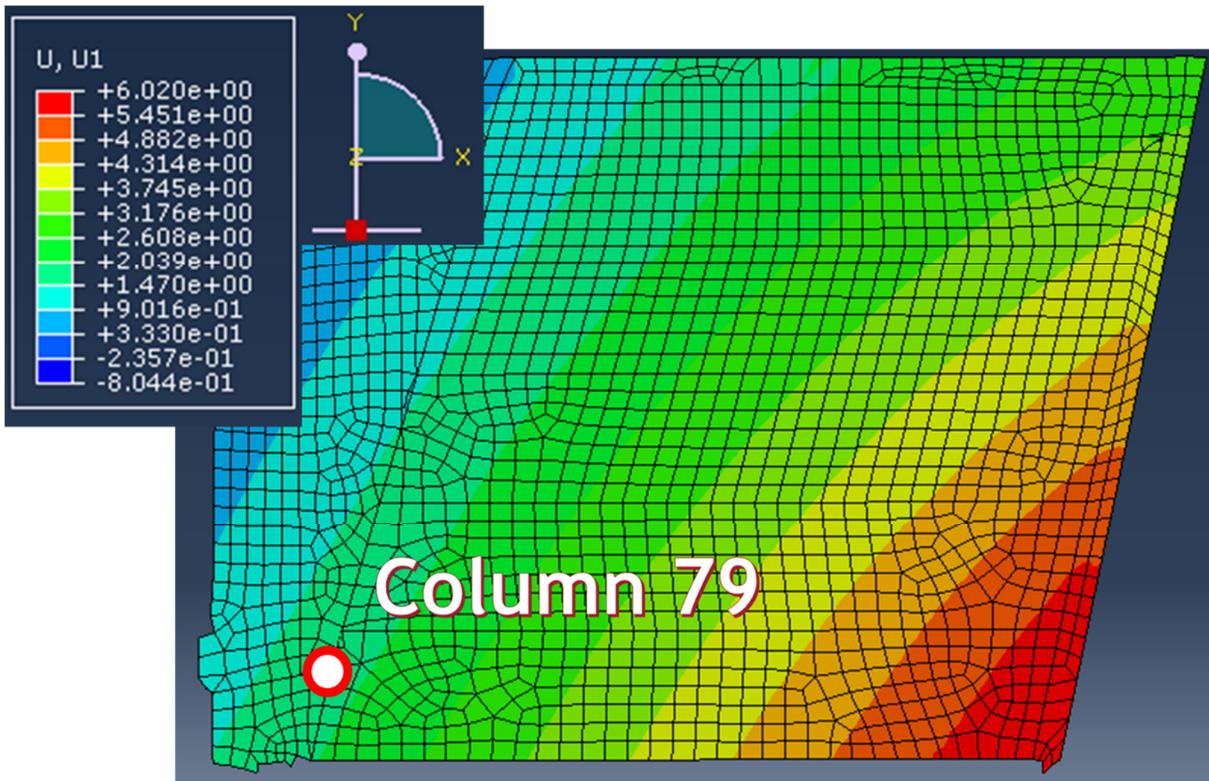
Figure 2.62 Movement in x -direction at Floor 13 around Column 79.

According to NIST, the initiating failure occurred at the connection between Column 79 and girder A2001 at Floor 13 due to a relative displacement of girder A2001 of 6.25 inches. Our ABAQUS analysis corroborated the findings of our SAP2000 analysis, showing that girder A2001 would undergo less than one inch of westward displacement relative to Column 79 under the worst-case fire condition. Examining all possible conditions, our analysis found that the westward movement of girder A2001 relative to the base plate on Column 79 was 3.68” for non-composite, 2.18” for partially composite and less than 1” for composite behavior (the condition at time of the fire).

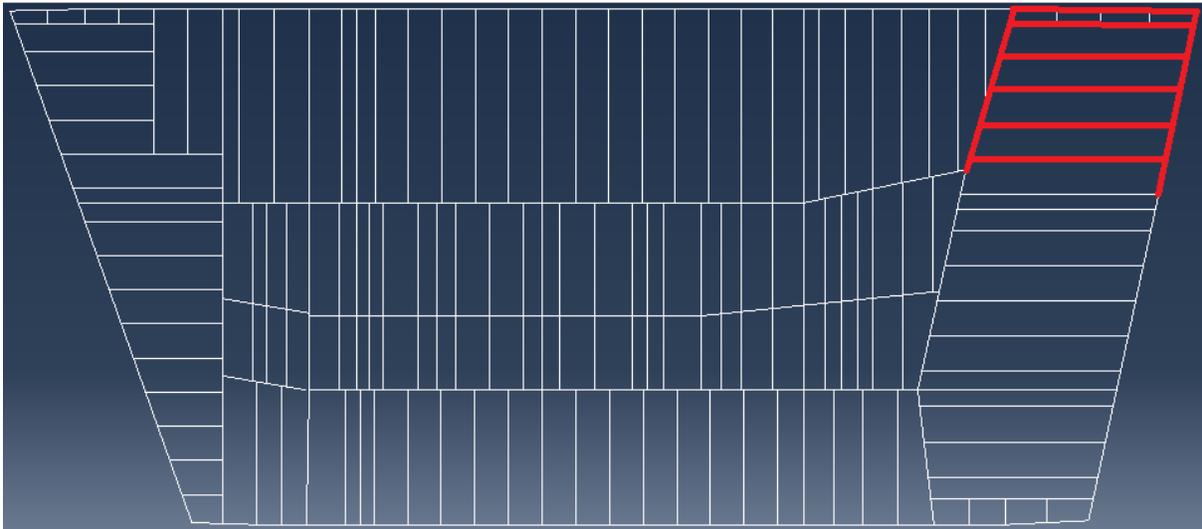
Figure 2.63 The part of the Floor 13 frame we examined is shown in red.

Subsequently, we studied the relative movement between Column 79 and girder A2001 in the worst-case condition to identify the maximum relative displacement at this connection in a higher temperature environment and without restriction from other frames, columns, and the deck. The part of the Floor 13 frame we examined is shown in red in Figure 2.63.

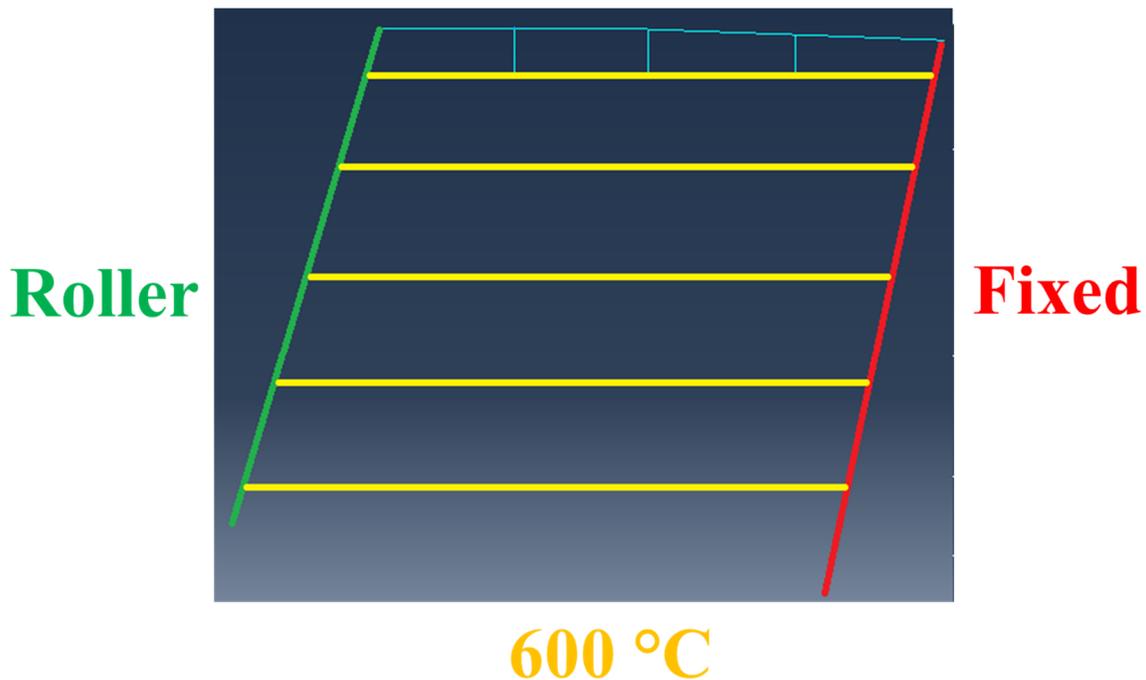
Figure 2.64 Local frame boundary conditions reported by NIST.

The boundary conditions reported by NIST and the assigned temperature distribution are shown in Figure 2.64 below. The concrete deck was not included in this model to ensure free expansion of the steel frame. The assigned temperature is also higher than the expected fire condition.

Figure 2.65 shows our calculation of the transverse displacement of the steel frame assuming the boundary conditions used by NIST. The horizontal displacement at the end of girder A2001 and Column 79 was calculated by our team to be 5.11 inches in the west direction. As stated above, it is important to note these boundary conditions, which were chosen by NIST, do not reflect the actual boundary conditions for Floors 12 and 13. The exterior frame is actually flexible and not fixed. The thermal point of zero movement is actually near the elevators where the building framing is stiffer. Furthermore, as stated above, all restrictions caused by other frames, columns, and the deck were excluded from this analysis.

When we incorporate NIST's boundary conditions and remove all restrictions to lateral movement, such as the Column 79 side plates, we find that the westward displacement of girder A2001 relative to Column 79 is 5.11 inches, which is a full inch less than the 6.25 inches of westward relative displacement reported by NIST, and nearly an inch less than the 6 inches westward displacement required to push the web of girder A2001 past its 12-inch seat at Column 79.

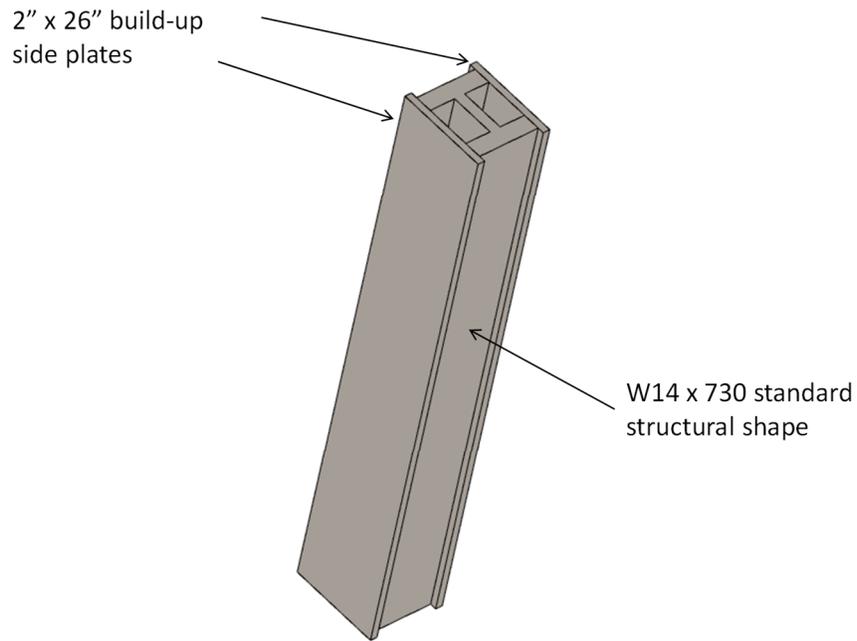
Figure 3.3 Column 79 section showing side plates welded to a W14x730.

Figure 3.3 shows the built-up configuration of Column 79 with its protruding side plates. Using the assumptions made by NIST, we analyzed the thermal response of Floor 13.

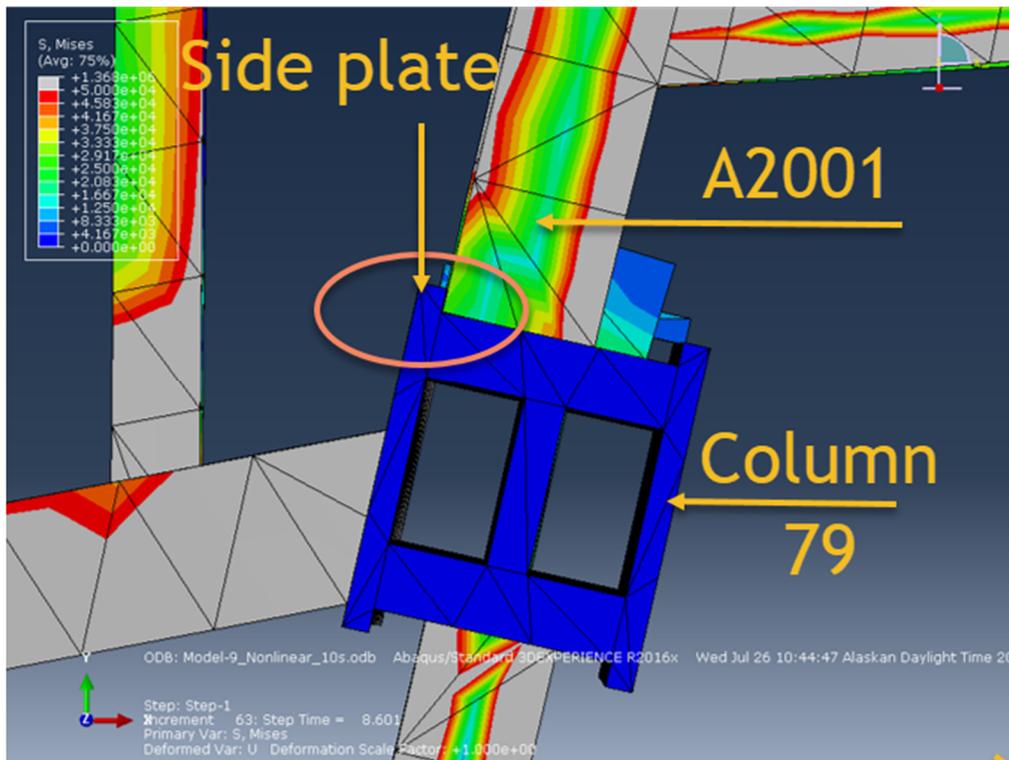
Figure 3.4 Plan view showing girder A2001 trapped by the Column 79 side plate.

First, we found that when girder A2001 is heated, it expands such that it becomes trapped behind the side plate on the western side of Column 79 as it is pushed to the west by thermally expanded beams K3004, C3004, B3004, A3004, and G3005 (see Figure 3.4).

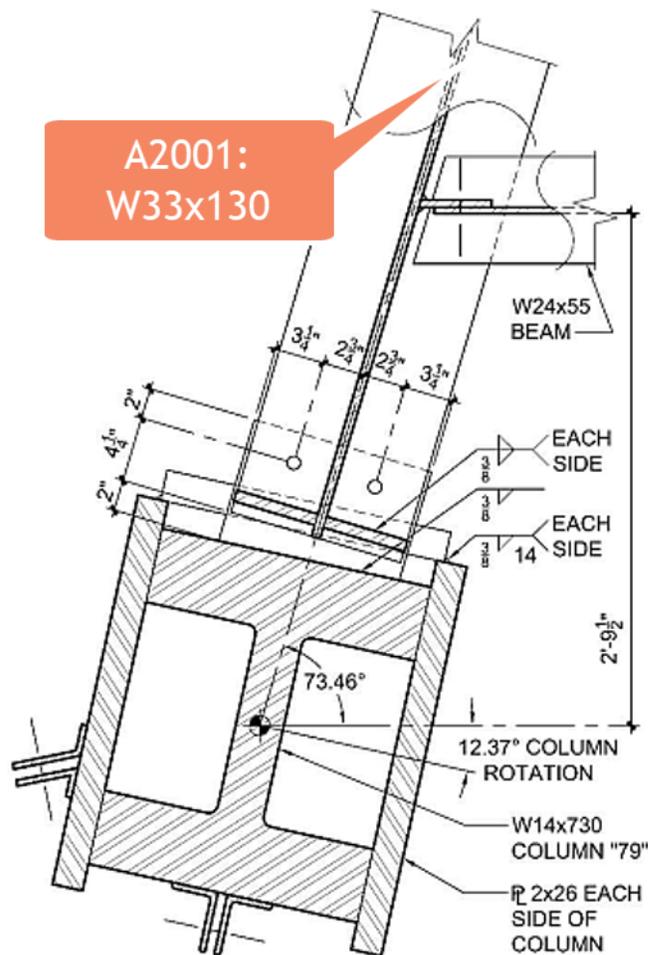
Figure 3.5 Plan View for Floor 13 at Column 79 and girder A2001 seat connection (Data from Frankel Steel Limited, 1985, Drawing 9114; figure prepared by Brookman, 2012).

Figure 3.5 shows the girder bearing seat at Column 79 is 12 inches wide. The flange width for W33 x 130 girder A2001 is 11.510 inches wide and centered on the seat; its web is 0.580 inches thick. This would require a lateral travel distance of 6.290 inches for the web to be beyond the seat. However, the distance between the column side plates is 17.89 inches. The girder and bearing seat are slightly off center to the east, with just 3.678 inches between the girder's western edge and Column 79's western side plate. Thus, the side plate prevents the girder's web from traveling beyond the bearing seat.

Given that the Column 79 side plate prevents the girder's web from traveling beyond the bearing seat, it appears that the structural analysis performed by NIST either minimized the side plate protrusion on Column 79 (nominally 1.79 inches) or ignored it altogether.

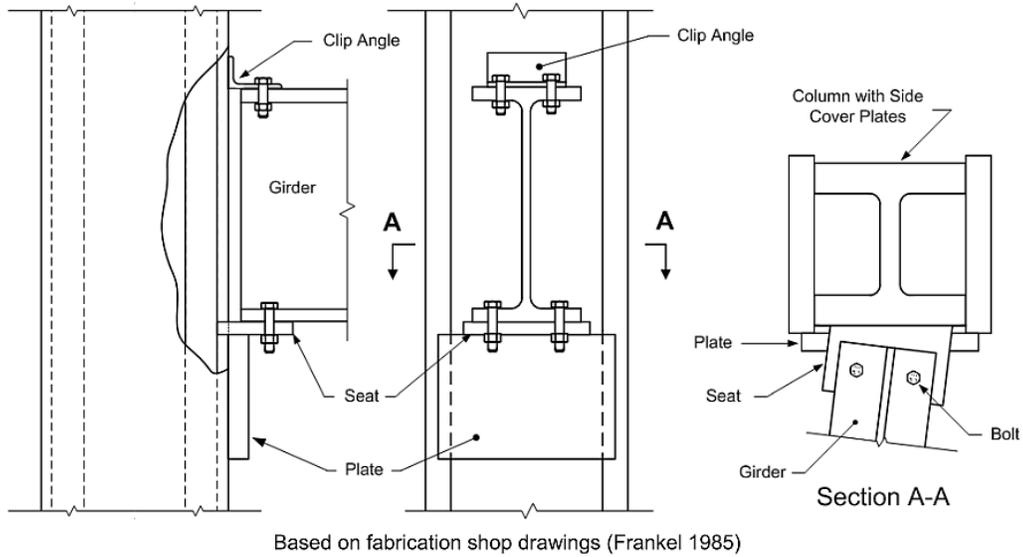
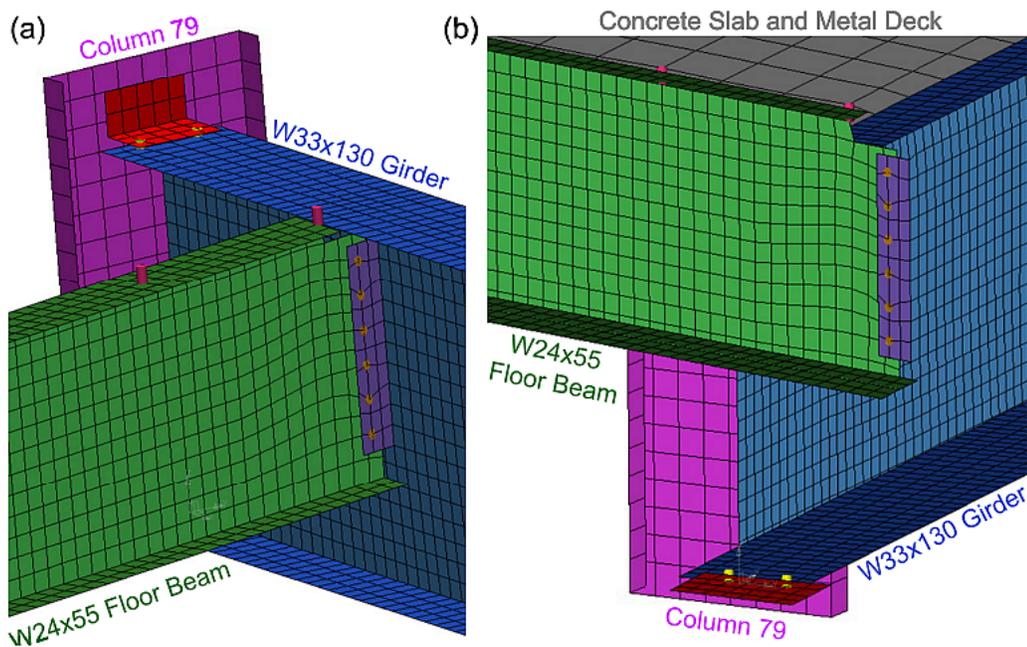
It is important to note that the analysis performed by NIST did not include the $\frac{3}{4}$ inch thick x 5.5 inch wide x 18 inch high partial height web stiffeners on girder A2001. Released fabrication shop drawing Frankel 9114 shows that the stiffeners were part of that structural member (Frankel Steel Limited, 1985). In addition to stiffening the web, these stiffeners significantly increase the bending resistance of the flange and would have prevented it from failing due to flexure (assuming the girder were somehow able to bypass the column side plate). Note that the small amount of high stress on the corner of the girder's flange is not in a load bearing area. This stress is due to the girder flange being slightly compressed in the axial direction by its contact with the column flange when the girder is thermally expanded. Figure 3.7 shows that the stresses in the girder flange and stiffener are not sufficient to cause the flange to fail.

Figures 3.8 and 3.9 below, which are from the NIST report, show that the NIST report's drawing and analysis figures omit these web stiffeners. Figure 3.10 shows the actual configuration.

Figure 3.8 Drawing of Column 79 and girder A2001 seated beam connection shown in Figure 8-21 of the NIST report.

Figure 3.9 Figure 8-23 of the NIST report showing NIST's finite element analysis of the Column 79 and girder A2001 seated beam connection.

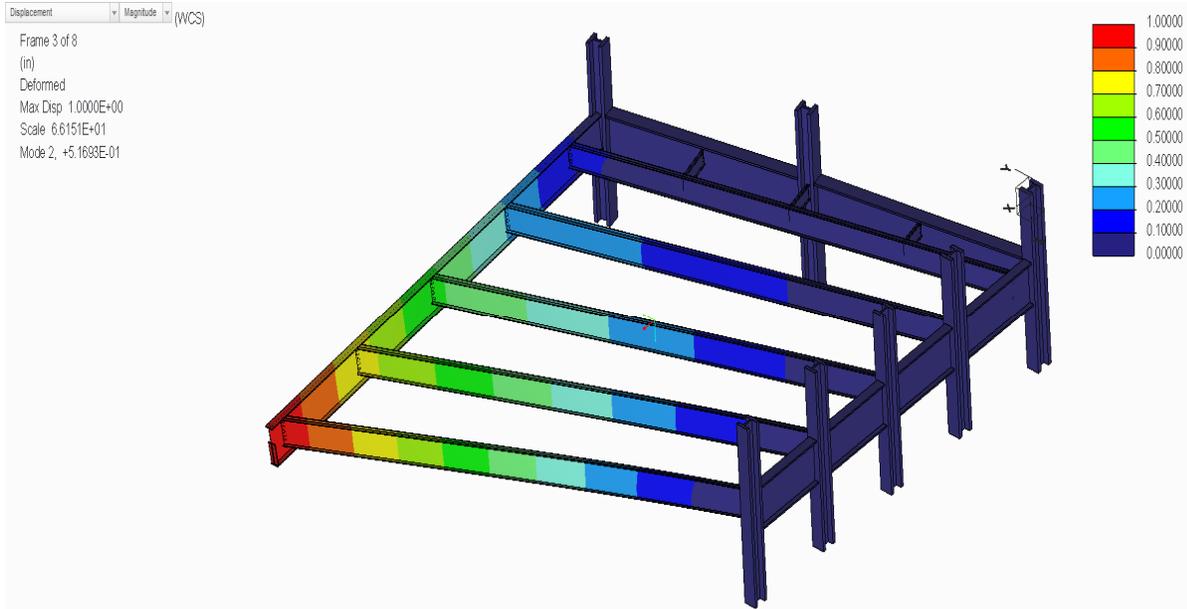
Figure 3.15 The relevant 0.52 Hz mode of the falling beam and girder assembly.

To determine the stiffness of the falling Floor 13 beam and girder assembly, a finite element modal analysis was performed with the assembly constrained at the north and east exterior walls and the girder sitting on its bearing seat at Column 44 with the bolts at the girder seat broken. The results are shown in Figure 3.15. The first mode of 22 Hz involved only the beams moving in a transverse direction and was not relevant. The second mode of 0.52 Hz involved the participation of the entire beam and girder assembly in the vertical direction and was relevant.

The natural frequency of mode 2 in the vertical direction is 0.51693 hz. The weight of the beam and girder assembly is approximately 20,000 lbs., so mass (m) = 20,000/32.174 = 622 slugs. The concrete was not considered by Nordenson to act with the steel during the impact to amplify the load. This would be appropriate as the shear studs were broken and the welded wire fabric in the slab and the floor pans would keep it suspended to some degree. Knowing the natural frequency of the beam and girder assembly (f_n), along with its mass (m), stiffness could then be found using the equation

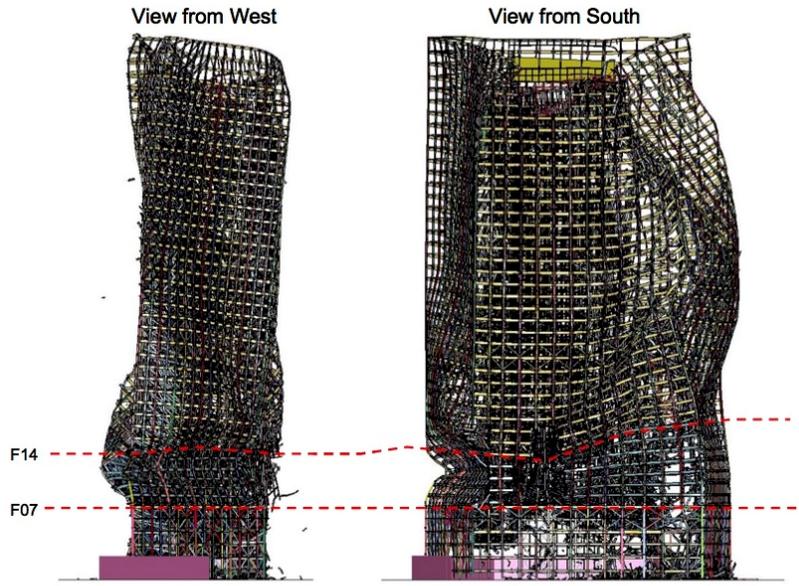
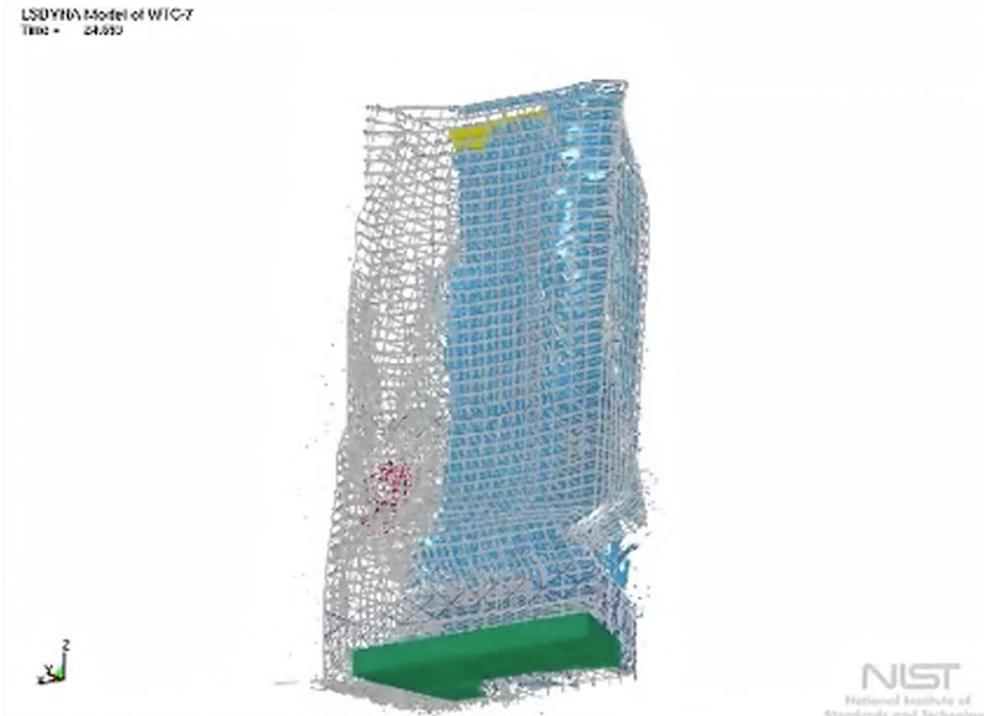
Figure 4.1 NIST’s progressive collapse simulation.

During our nonlinear connection study (Section 2.1.3.2), wherein we examined NIST's modeling of WTC 7's structural connections and its effect on NIST's progressive collapse simulation, we also observed that NIST's progressive collapse simulation did not closely resemble the observed collapse. While NIST's progressive collapse simulation does show the three key features listed above, it also predicts significant differential movements in the exterior, both before and during the fall of the roofline, that were not observed in the video (see Figures 4.1a and 4.1b). Such differential movements in the exterior would be extremely likely to have caused window breakage, cracking of the façade, and exterior deformation, none of which were observed. A major goal of our analysis was to identify failure mechanisms that would predict the minimal differential movement of the exterior seen in videos of the collapse.

(a) Illustration of NIST’s progressive collapse simulation showing significant differential movements in the exterior (NIST NCSTAR 1-9).

(b) NIST’s progressive collapse simulation showing significant differential movements in the exterior (NIST NCSTAR 1A).

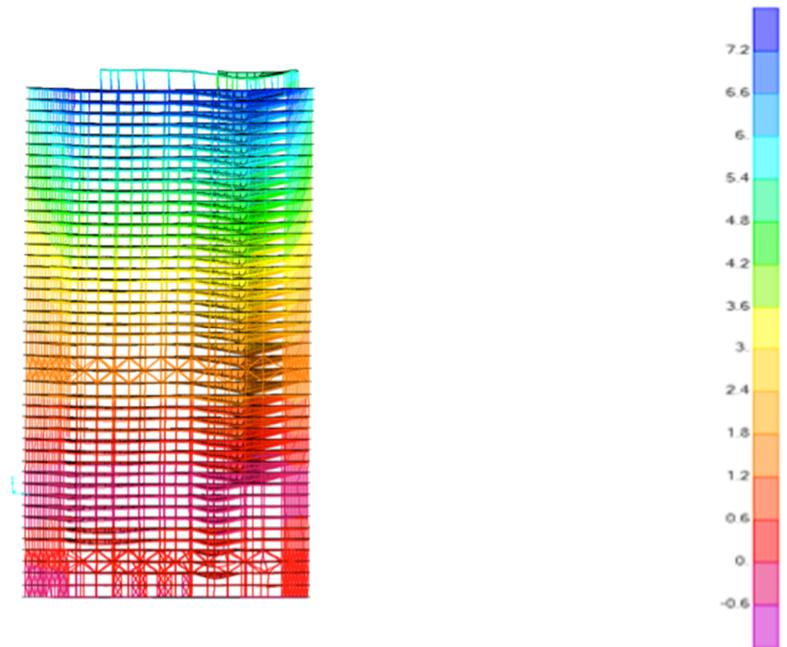
Figure 4.3: Columns 79, 80, and 81 are removed from Floor 13 to Floor 21. The building tilts to the east 7.2 inches. The penthouse does not collapse.

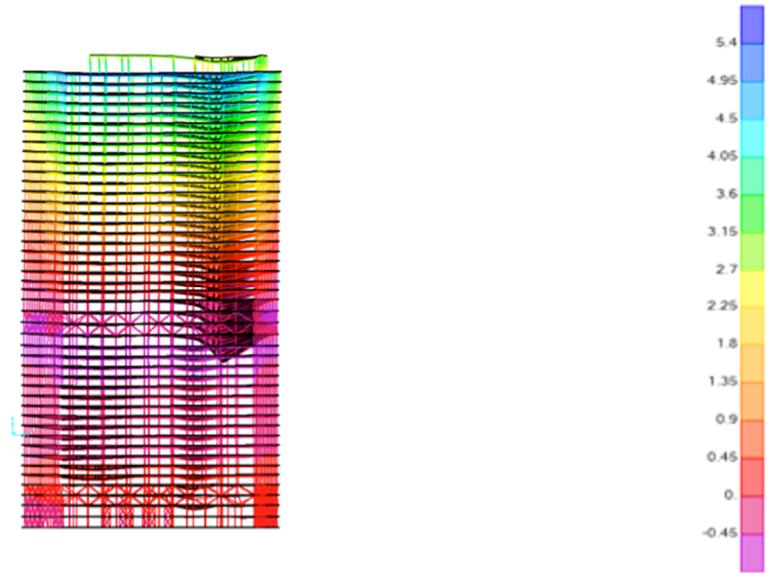
Figure 4.4: Columns 79, 80, and 81 are removed from Floor 21 to Floor 29. The building tilts to the east 5.4 inches. The penthouse does not collapse, though penthouse deflection increases.

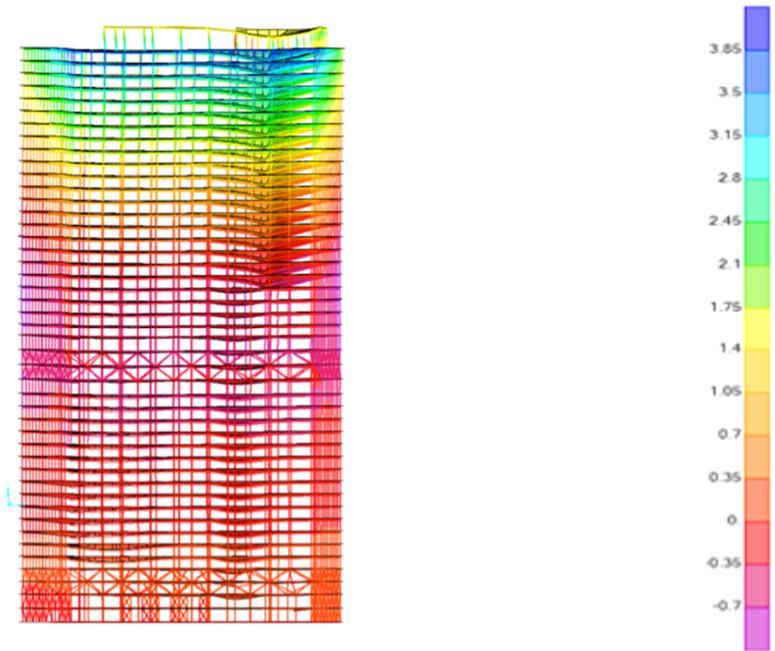
Figure 4.5: Columns 79, 80, and 81 are removed from Floor 29 to Floor 37. The building tilts to the east 3.85 inches. The penthouse does not collapse, though its deflection increases.

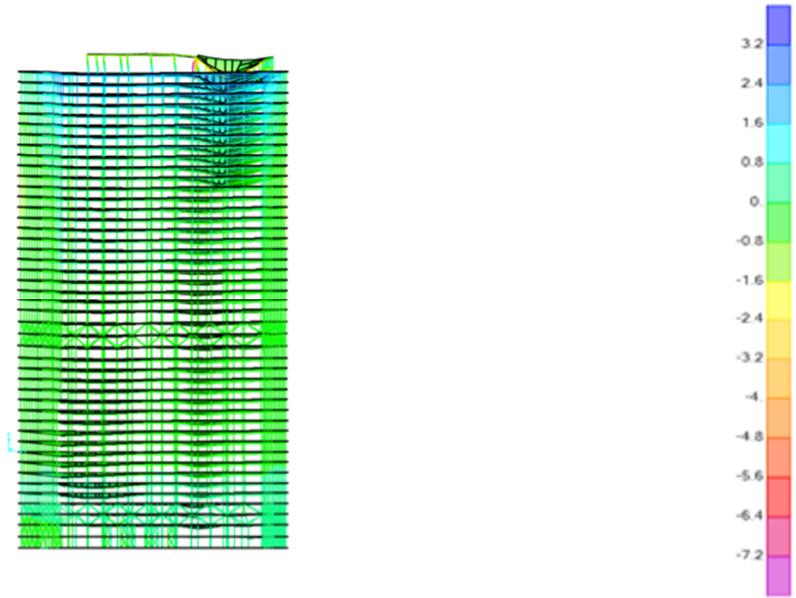
Figure 4.6: Columns 79, 80, and 81 are removed from Floor 37 to Floor 45. Tilting of the building is now negligible, whereas the deflection of the penthouse is now much greater.

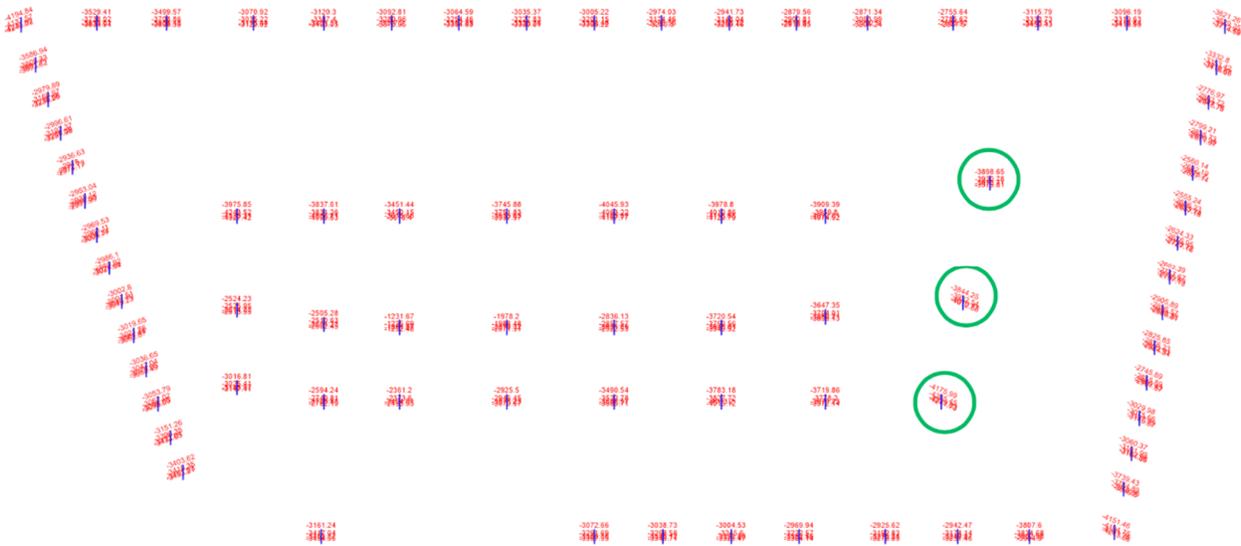
1. A horizontal progression of core column failures — starting with Columns 79, 80, and 81 — was not feasible. Therefore, the hypotheses of NIST, Arup/Nordenson, and Weidlinger that the buckling of Column 79 could trigger a progressive collapse of the entire building are invalid.
2. Even if we assume the failure of Columns 79, 80, and 81 could lead to the failure of the next row of core columns — Columns 76, 77, and 78 — the loss of these columns along with the loss of Columns 79, 80, and 81 would overload the exterior columns around the southeast corner of the building rather than overloading the next row of core

Figure 4.8: Linear static analysis of Columns 79 to 81 (circled in green) being removed.

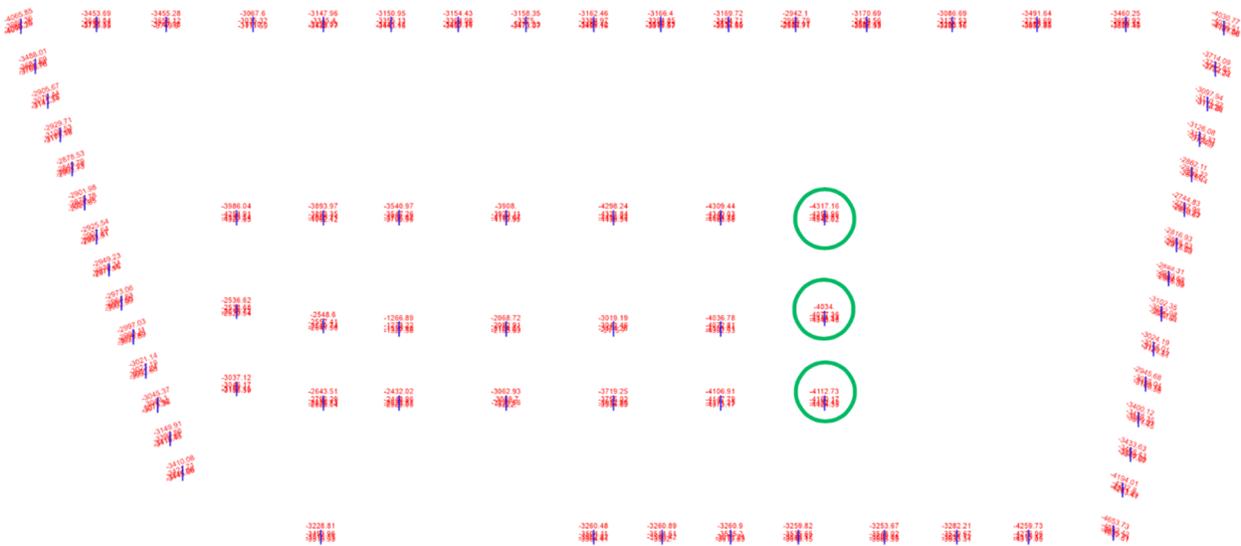
columns to the west, which would result in the building tipping to the southeast and not in a straight-down collapse.

Figure 4.9: Linear static analysis of Columns 76 to 81 (circled in green) being removed.

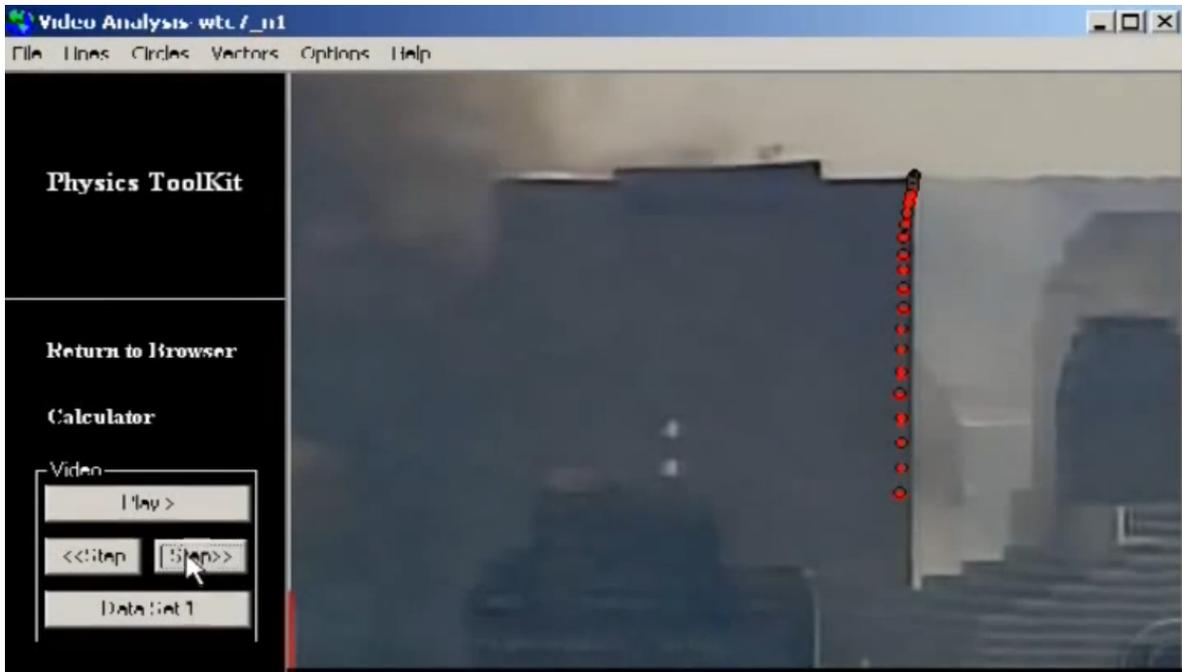
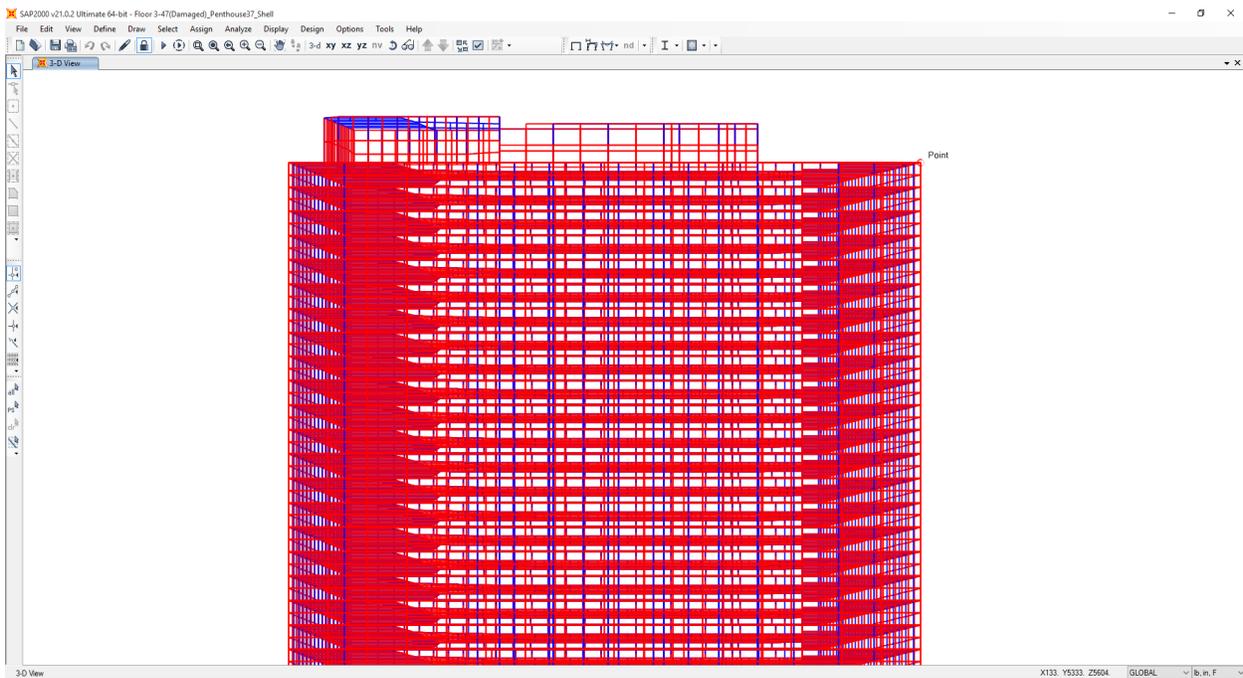
Based on this analysis, we found that the simultaneous failure of all core columns followed by the simultaneous failure of all exterior columns produces almost exactly the behavior observed in videos of the collapse. Specifically, the simulated velocity and acceleration of the building in our SAP2000 model matches almost exactly with the motion measured by David Chandler (Chandler, 2010), including the approximately 2.5 seconds of free fall, shown in Figures 4.21, 4.22, and 4.23 below.

Figure 4.21: Velocity analysis by David Chandler (Chandler, 2010).

Figure 4.22: Simulation of core column-exterior column failure scenario.

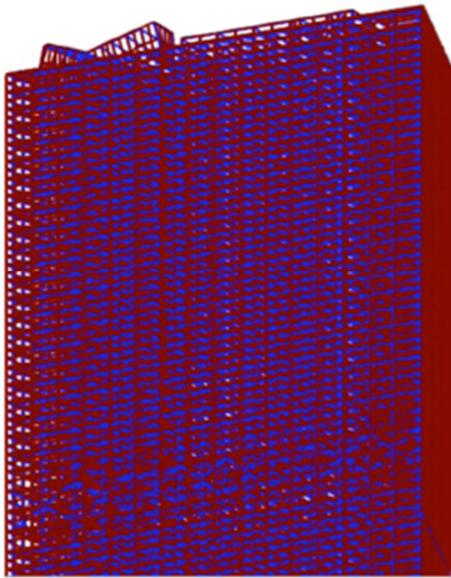
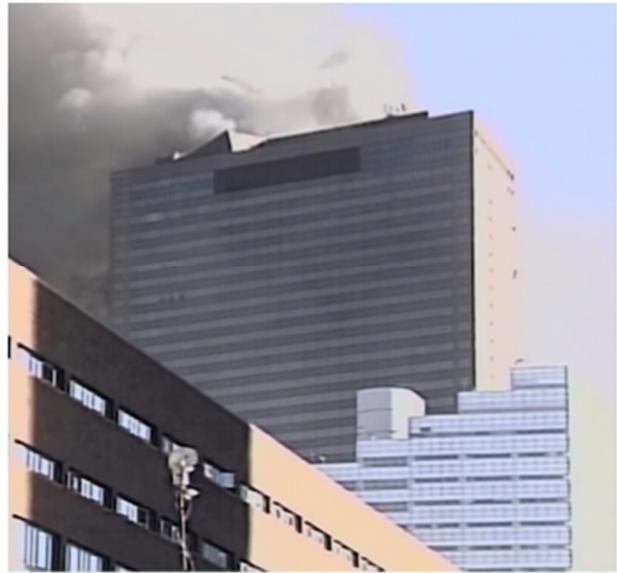
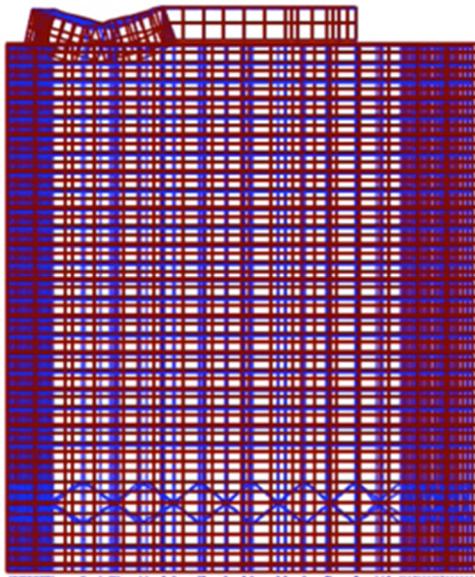
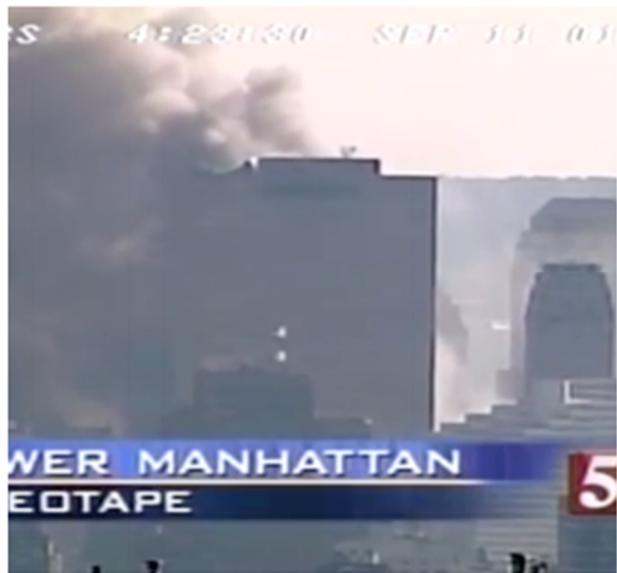
Figure 4.24: (a) Comparison of simulated collapse to perspective 1; (b) comparison of simulated collapse to perspective 2.

The simulated collapse was examined in two different perspectives to match the perspectives of video captured from two separate angles. Figure 4.24 below shows the UAF simulation side-by-side with the two videos of the collapse.

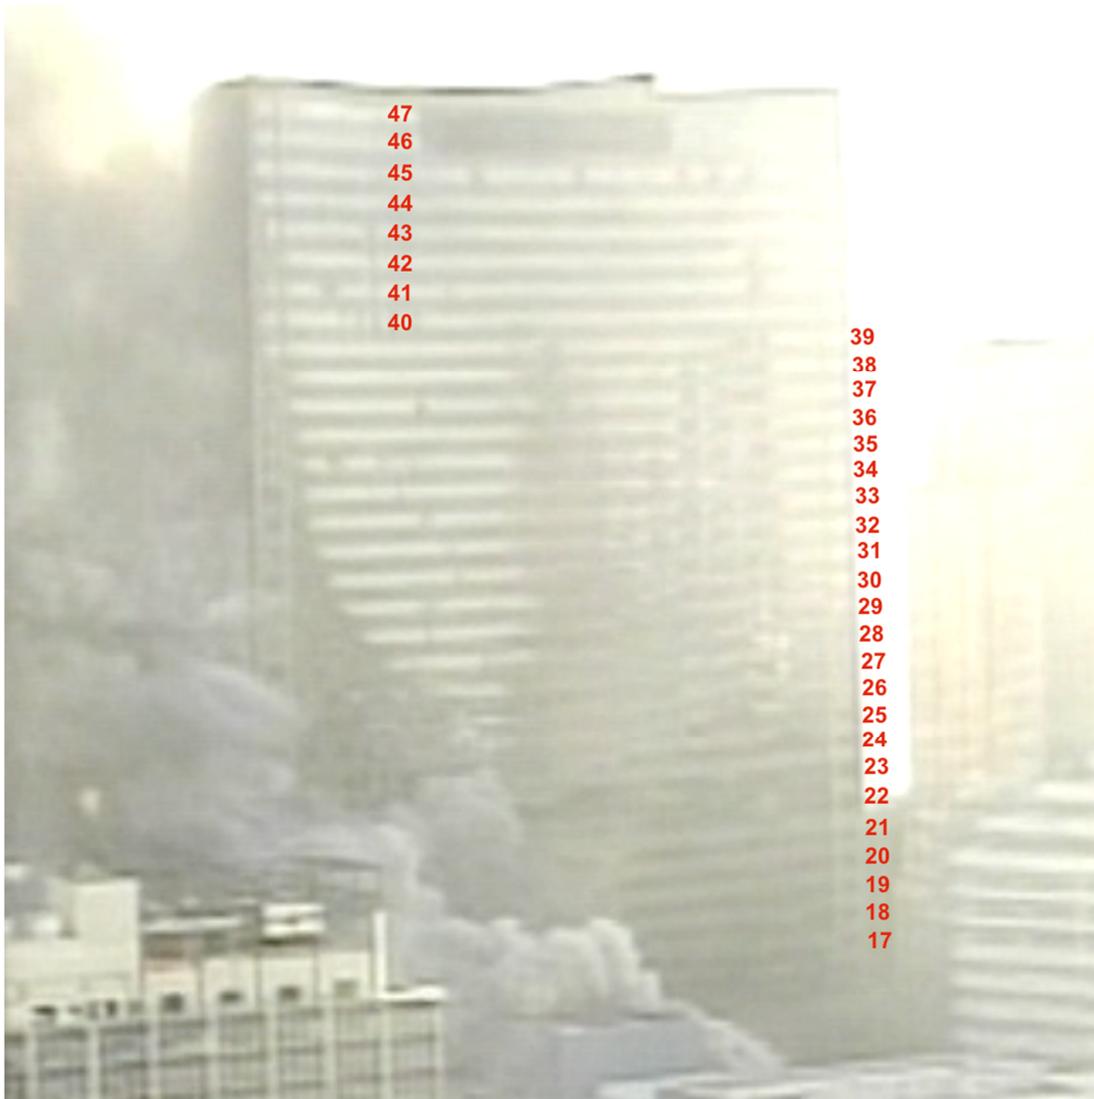
Figure 4.25: Floors 17 to 47 falling uniformly as a unit (CBS).

12 to Floor 19; the second was the failure of all columns from Floor 6 to Floor 13. The two simulations were identical in terms of the downward velocity and acceleration of the northwest corner at the top of building. We therefore found that the collapse could have started at various floors. Based on our subsequent review of video footage, we found that Floor 16 is the uppermost floor where the collapse could have initiated, because the video shows Floor 17 to Floor 47 falling uniformly as a unit (see Figure 4.25 below). Although some floors below Floor 17 are somewhat visible in the video, it cannot be determined with confidence that they are falling as a unit with the floors above.
